# **DELTA COLLEGE**

## **FACILITIES CONDITION ASSESSMENT**

DSD Project No. 20-0501

UNIVERSITY CENTER, MICHIGAN

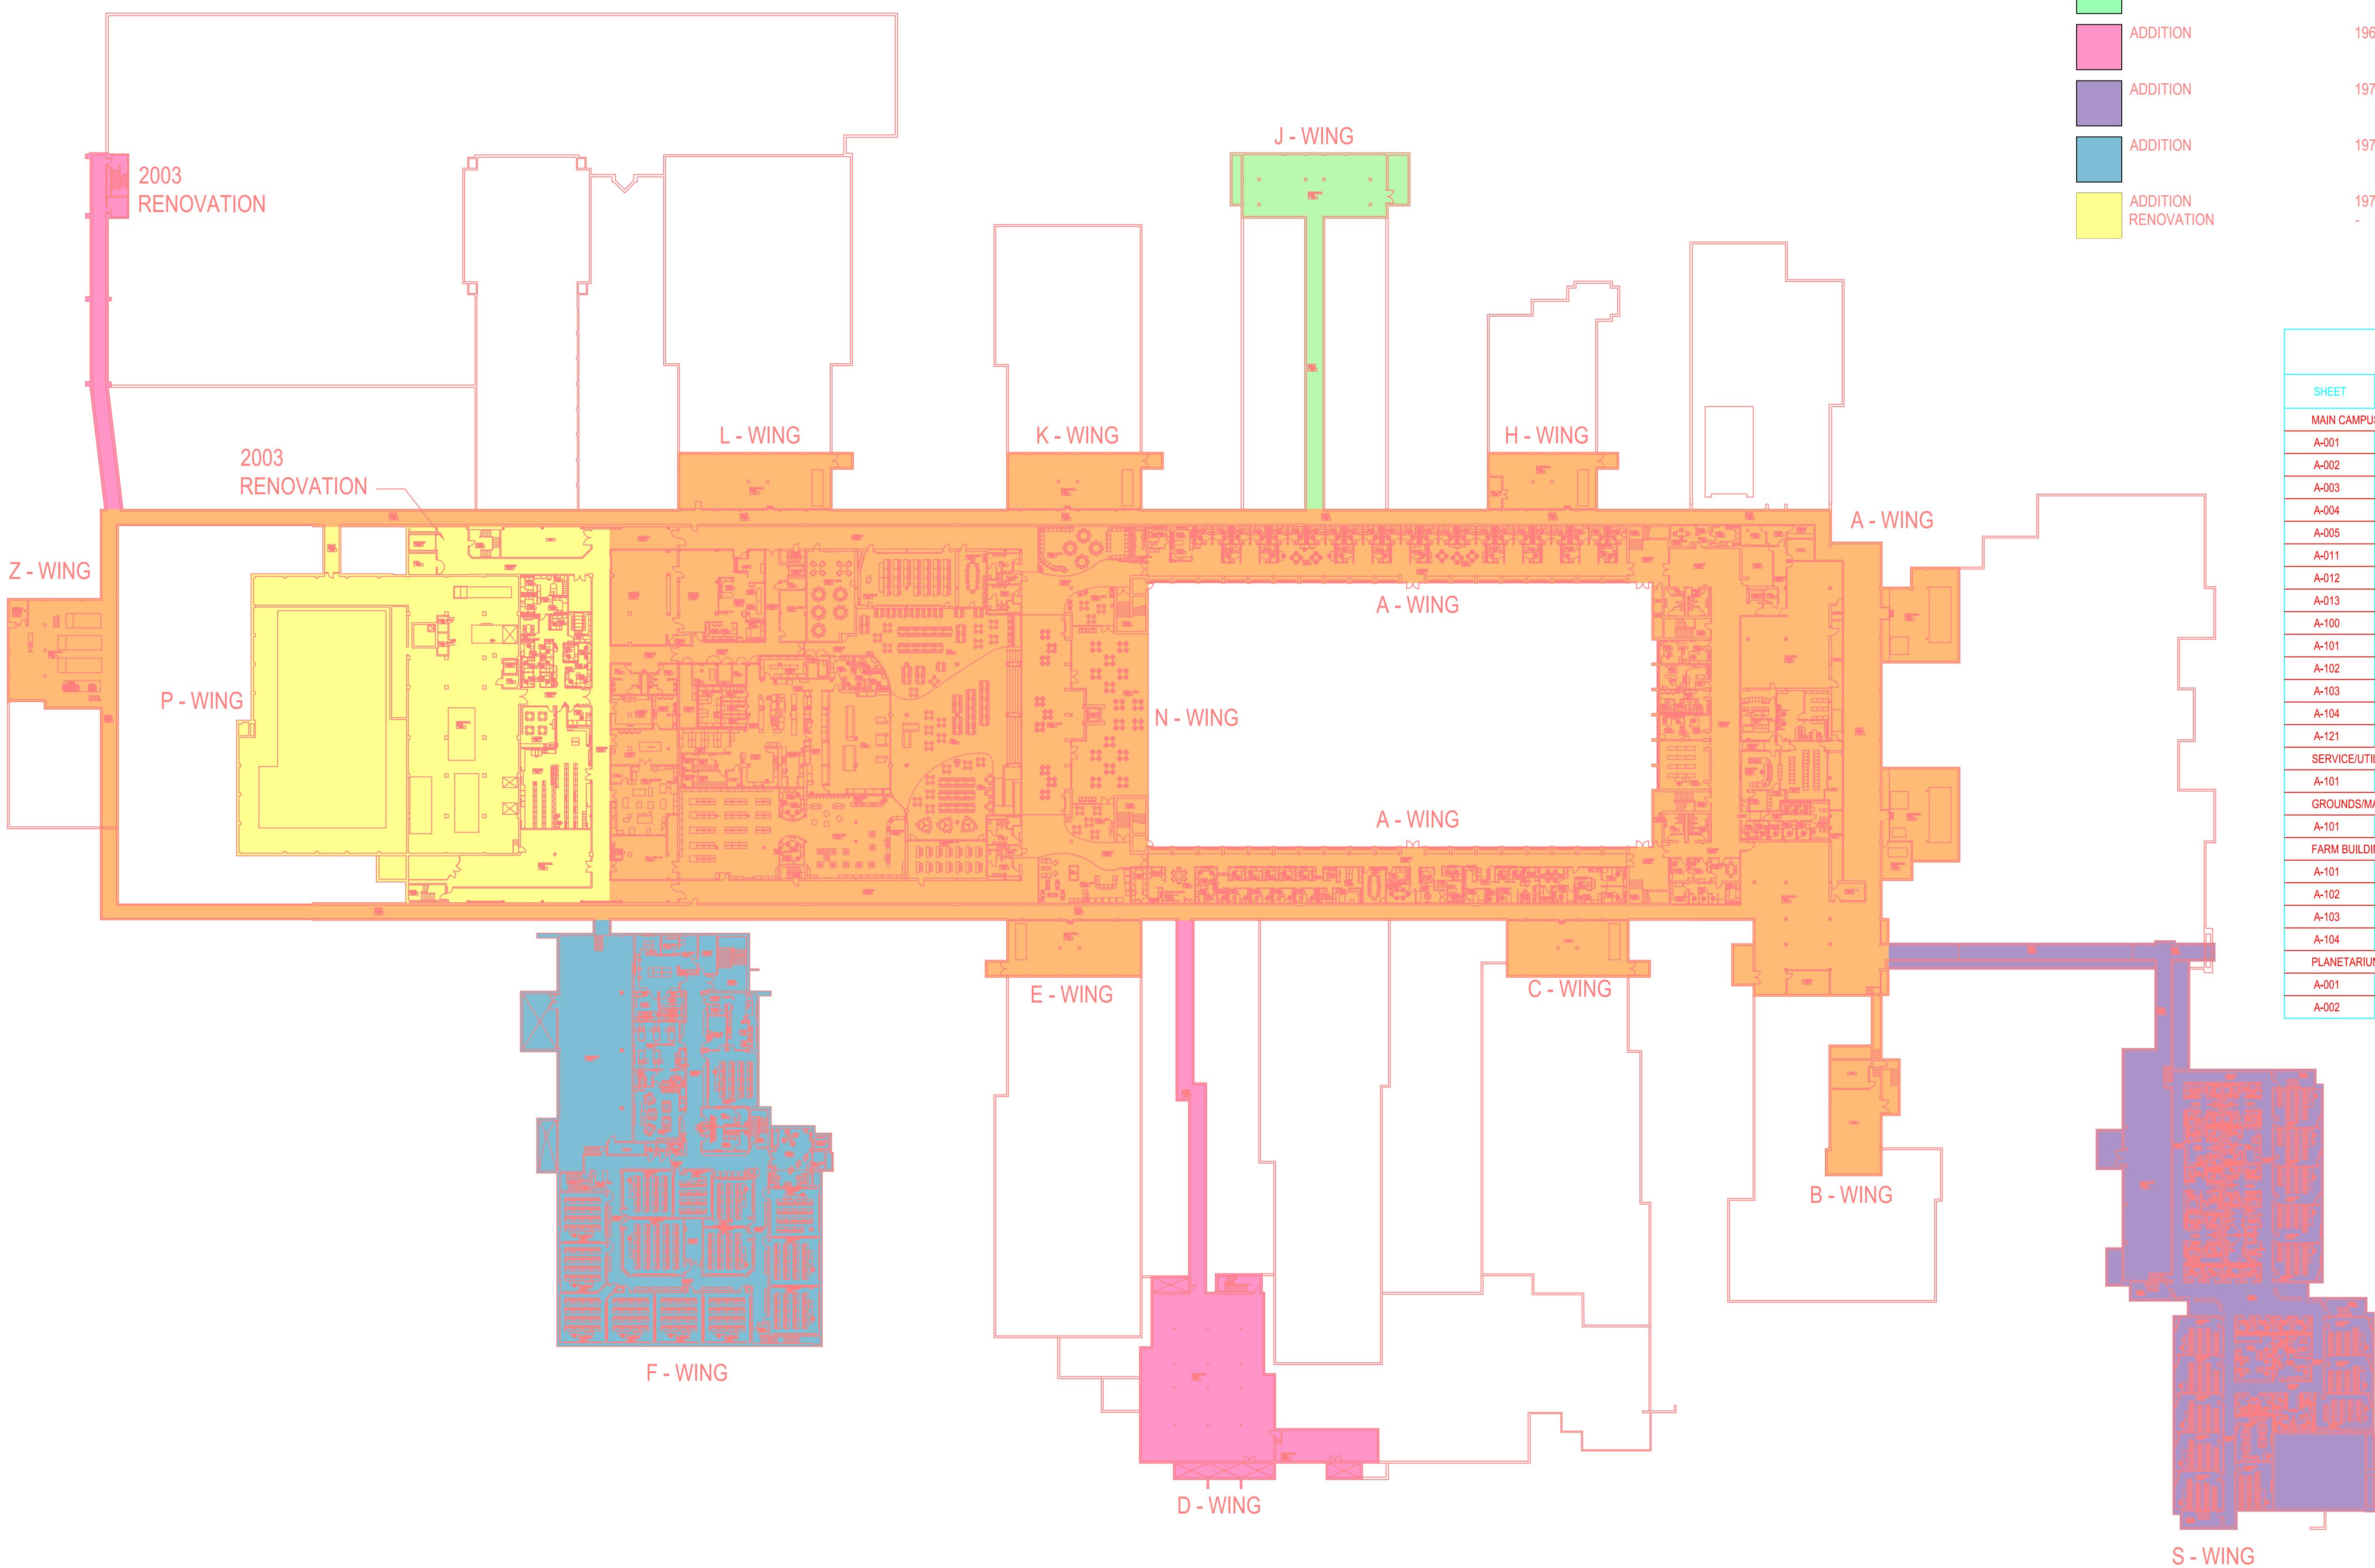
LOWER LEVEL  
PHASING PLAN  
SCALE: 1" = 50'  
0 25 50 100 Feet

DESIGNER:	DA
MODELER:	DA
PM:	ATW
PIC:	BUR
ACADFILE:	202001-A001.DWG
PROJECT No:	20-0501.00
SHEET TITLE	MAIN CAMPUS LOWER LEVEL PHASING PLAN
SHEET NUMBER	A-001

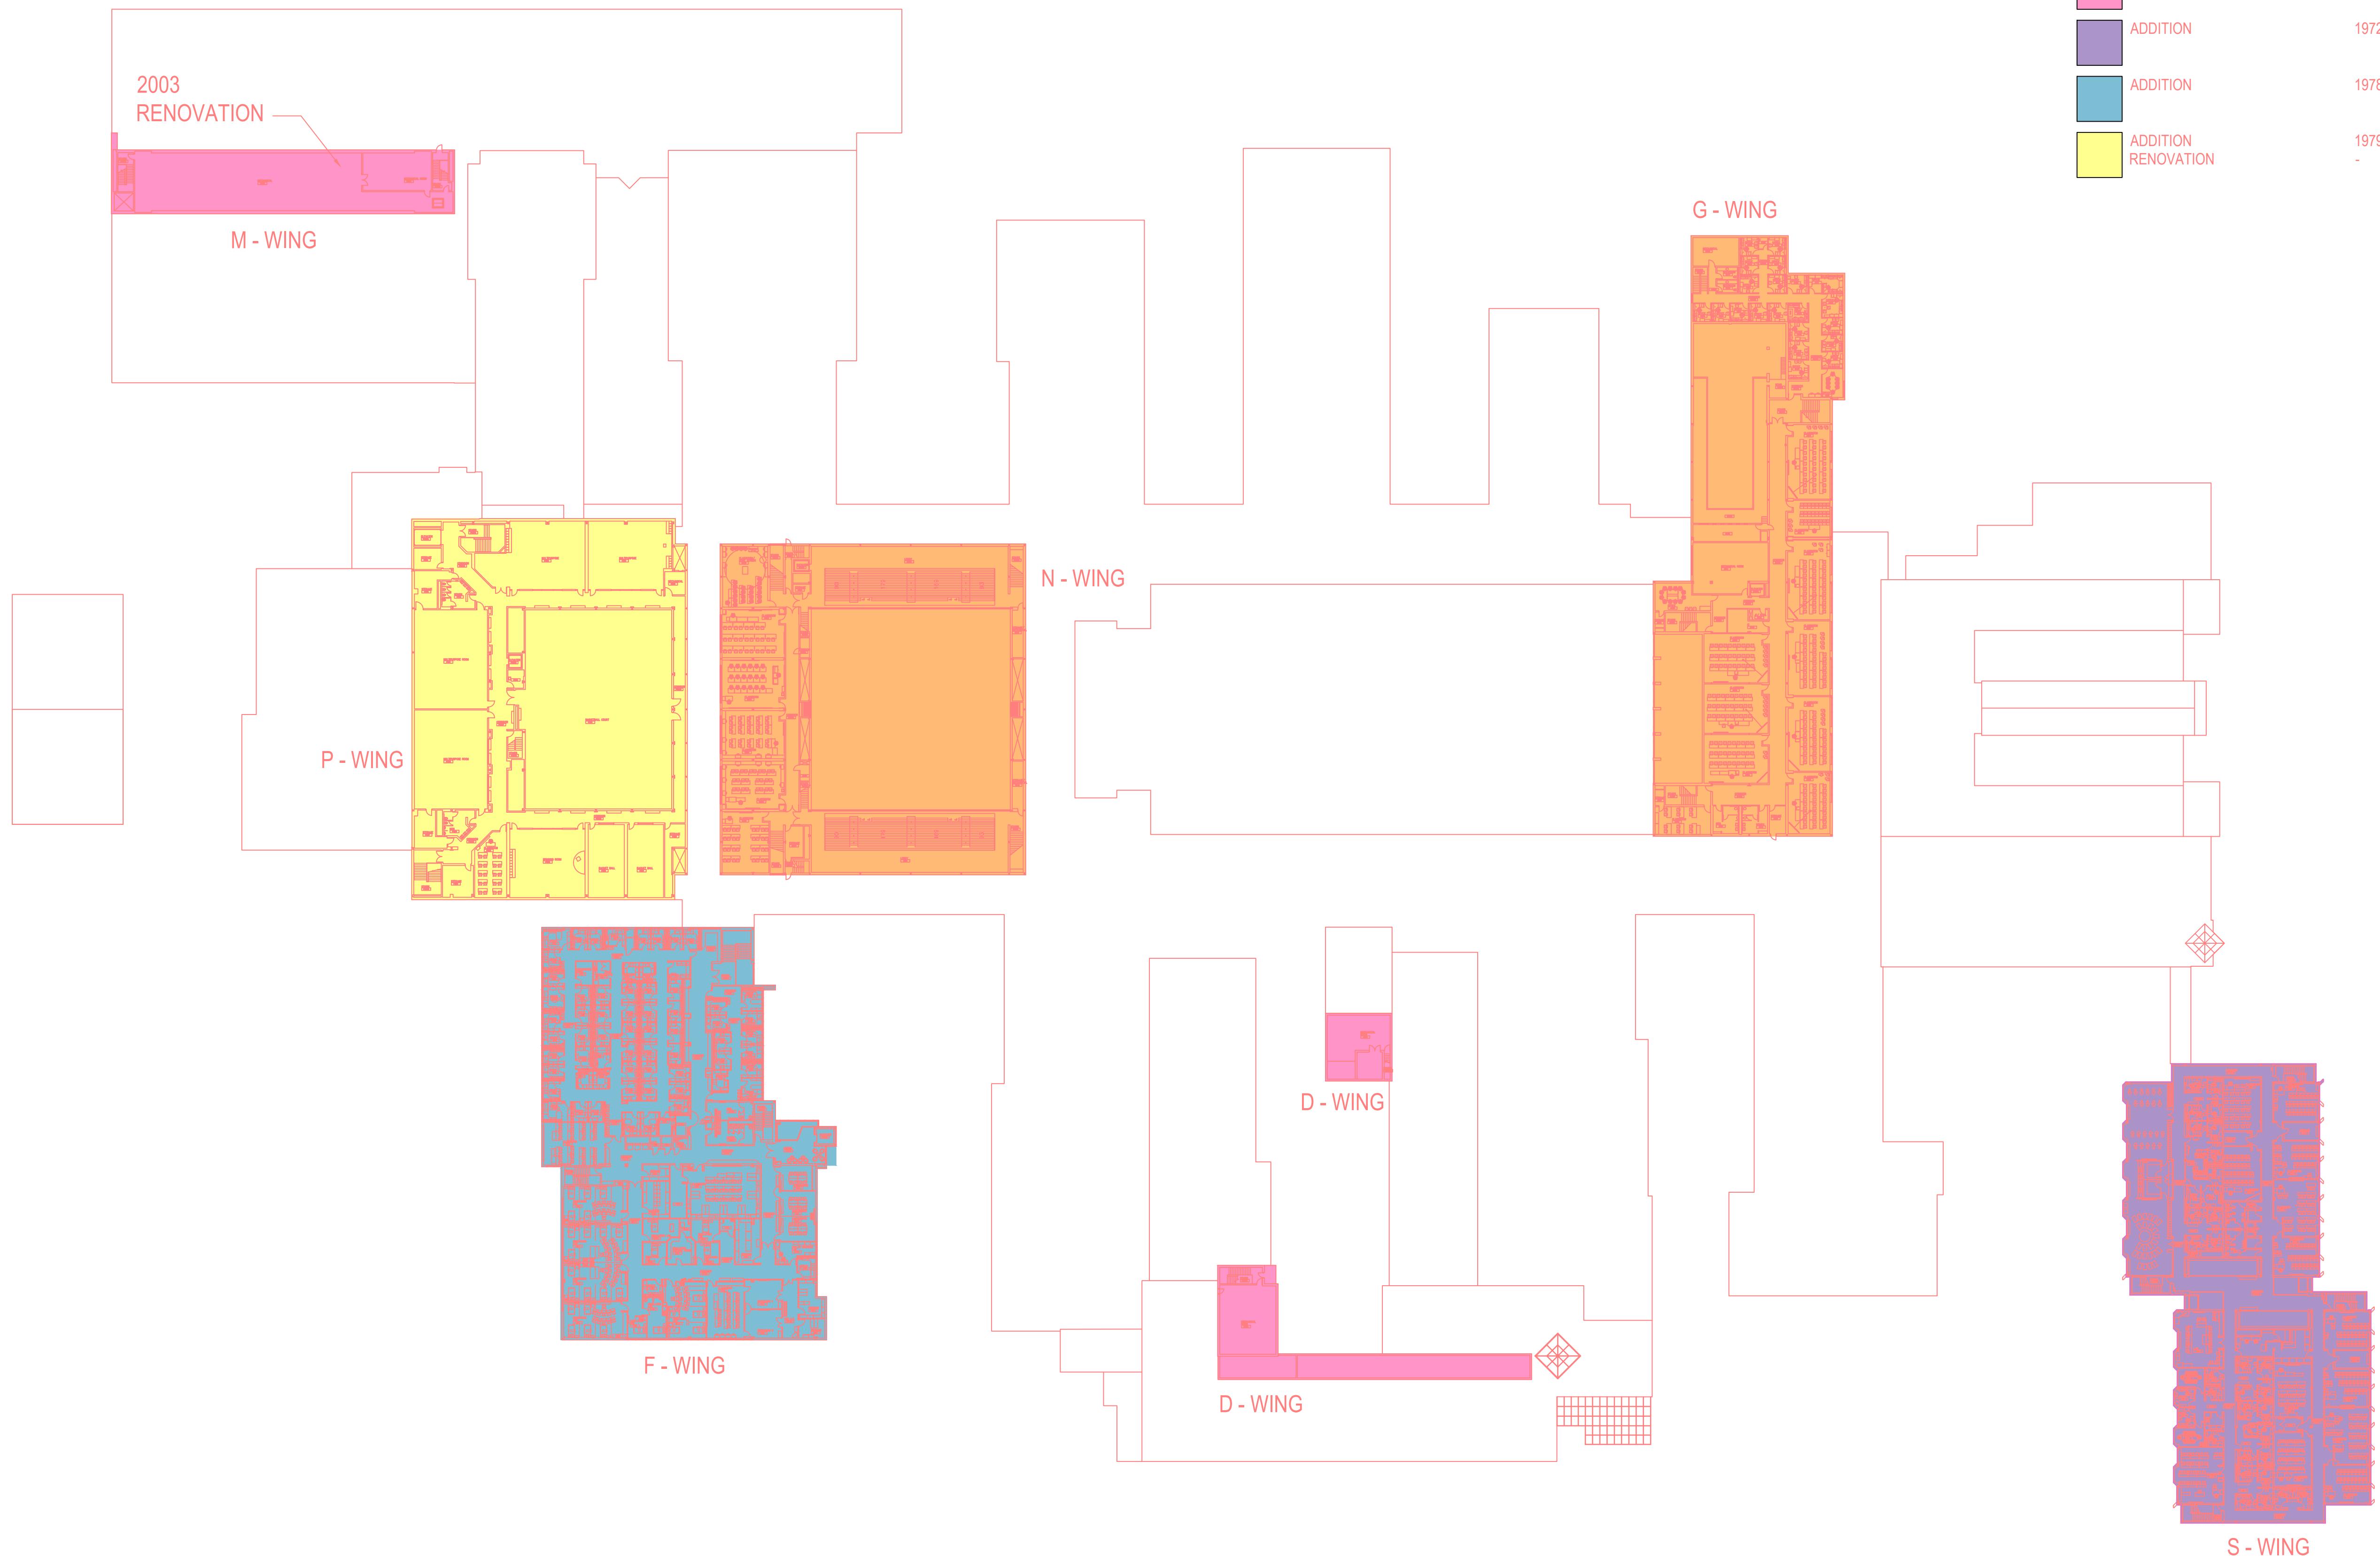
COND FLOOR  
EASING PLAN

## MAIN CAMPUS SECOND FLOOR PHASING PLAN

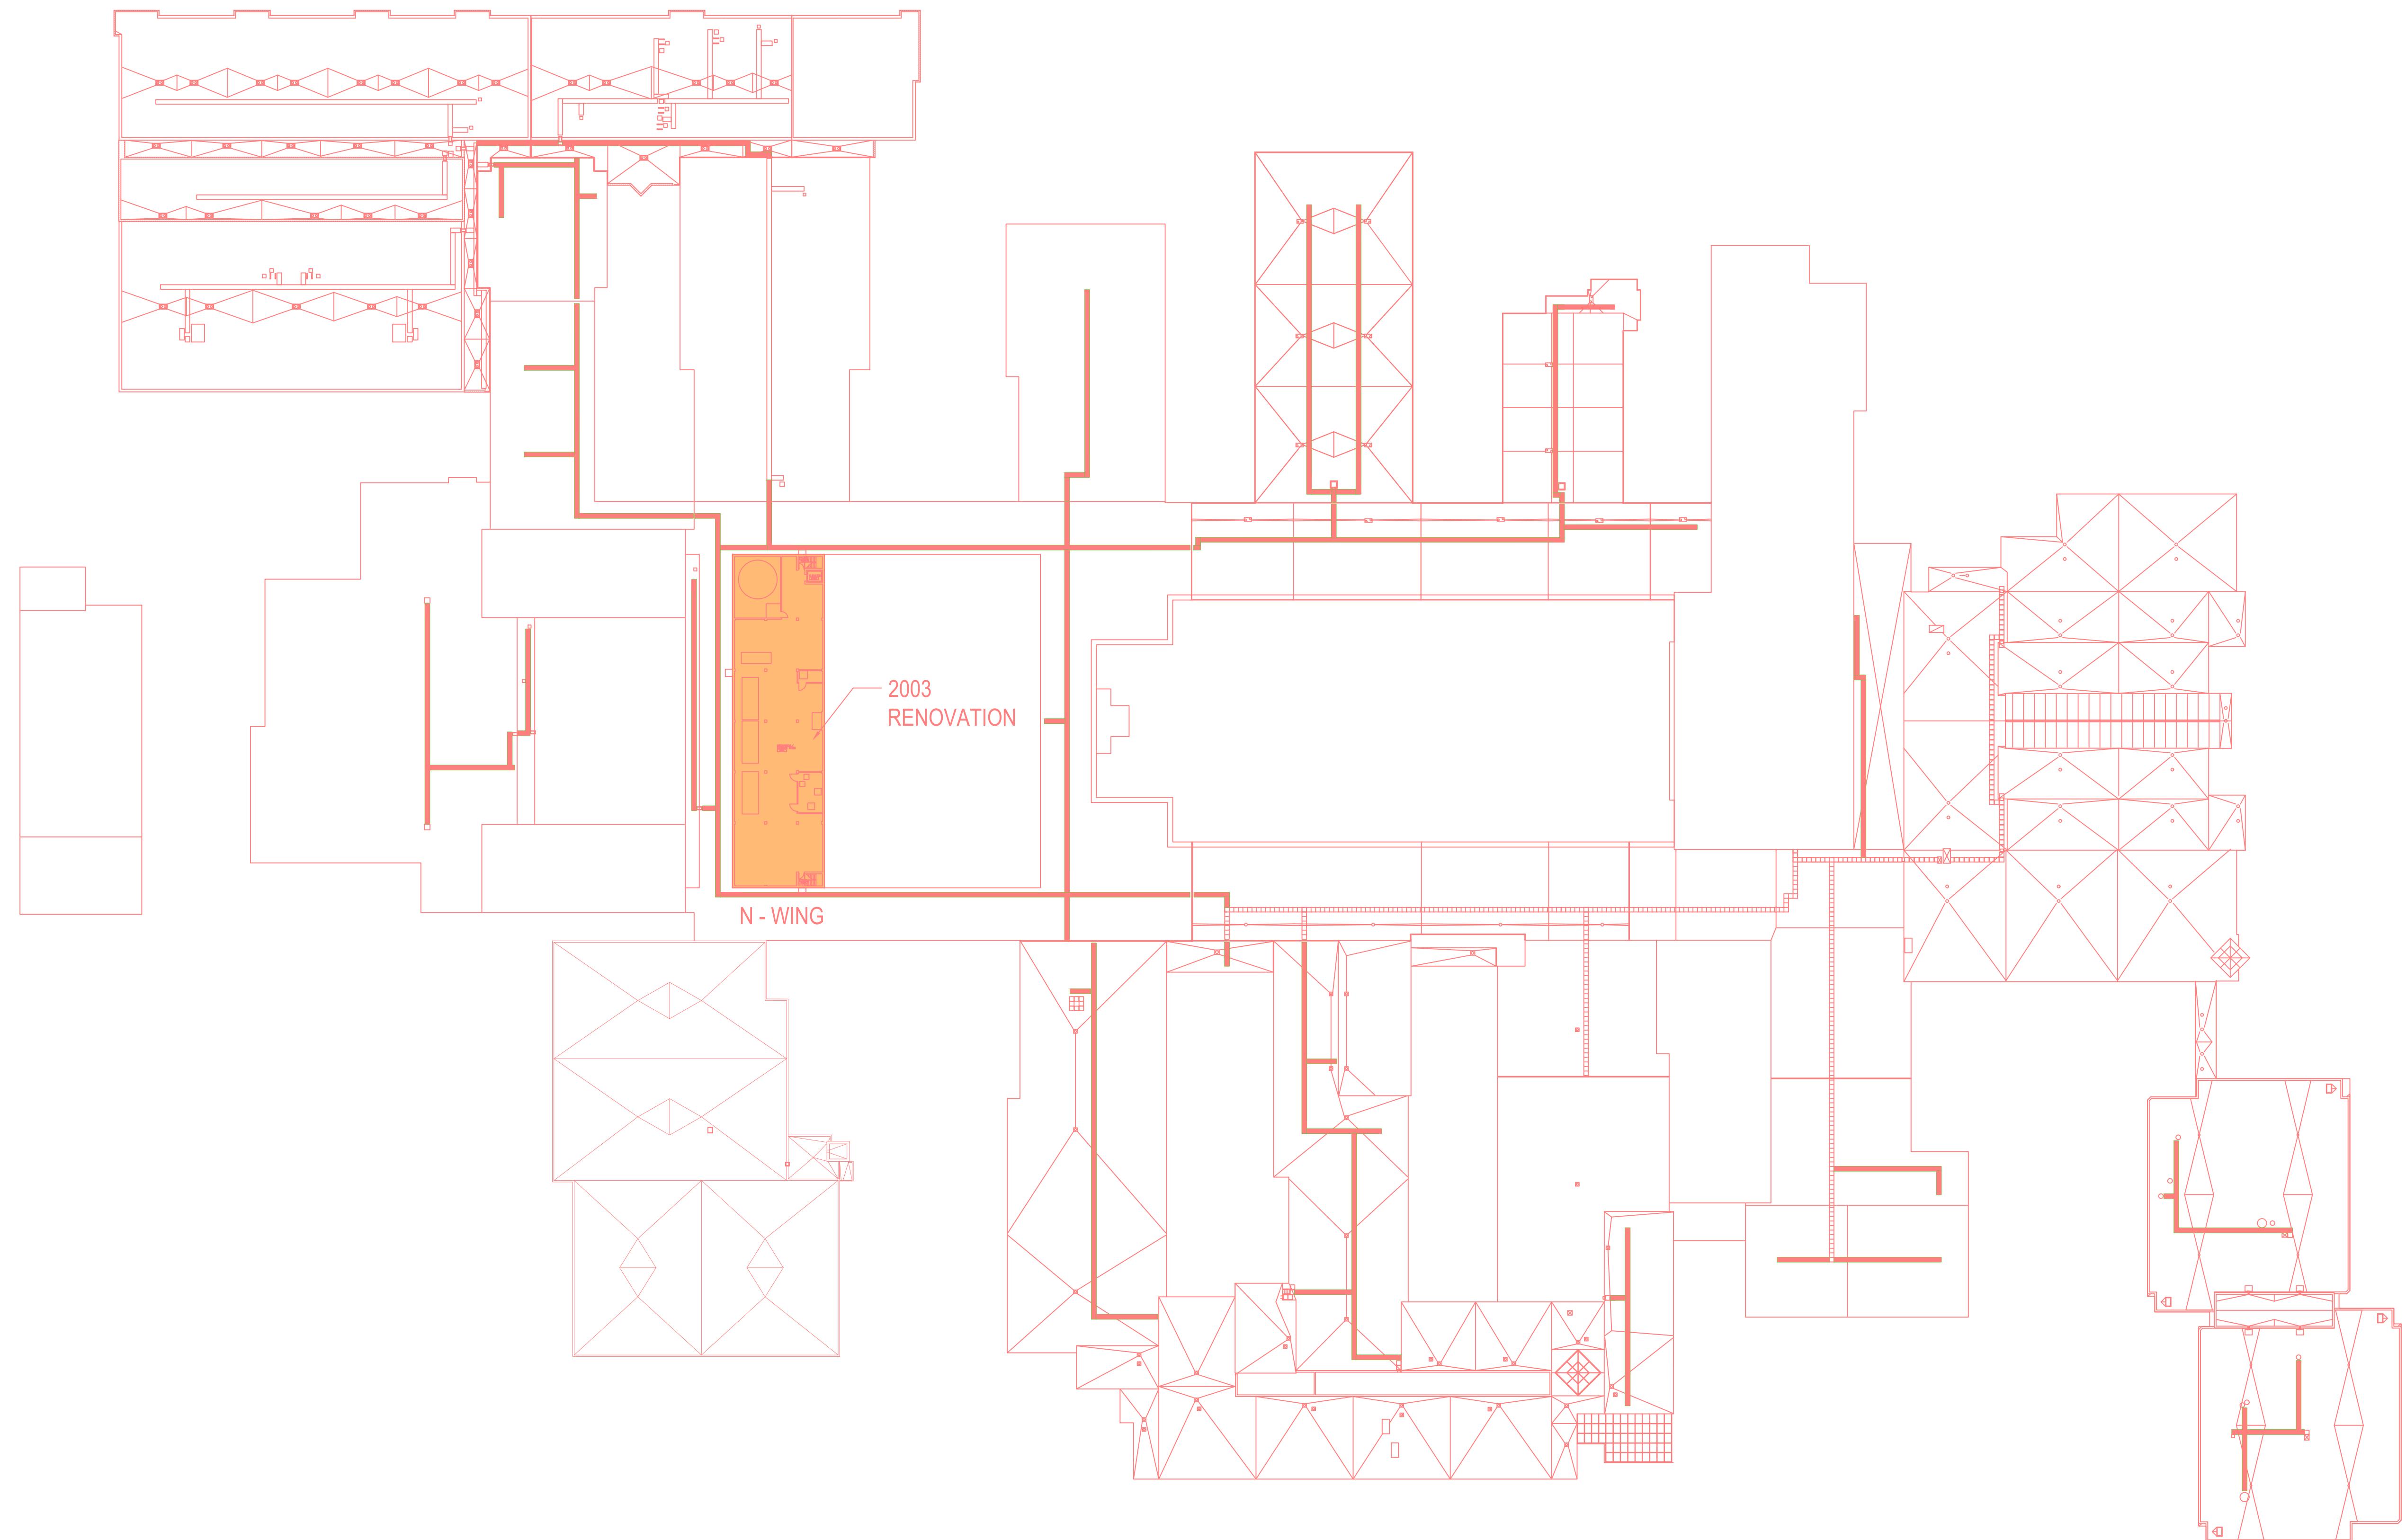
NUMBER  
A-004

OWNER:	DA
SELLER:	DA
	ATW
	BJR
FILE:	20-0501-A-004.DWG
ECT No.	20-0501.00
TITLE	
MAIN CAMPUS	
THIRD FLOOR	
PHASING PLAN

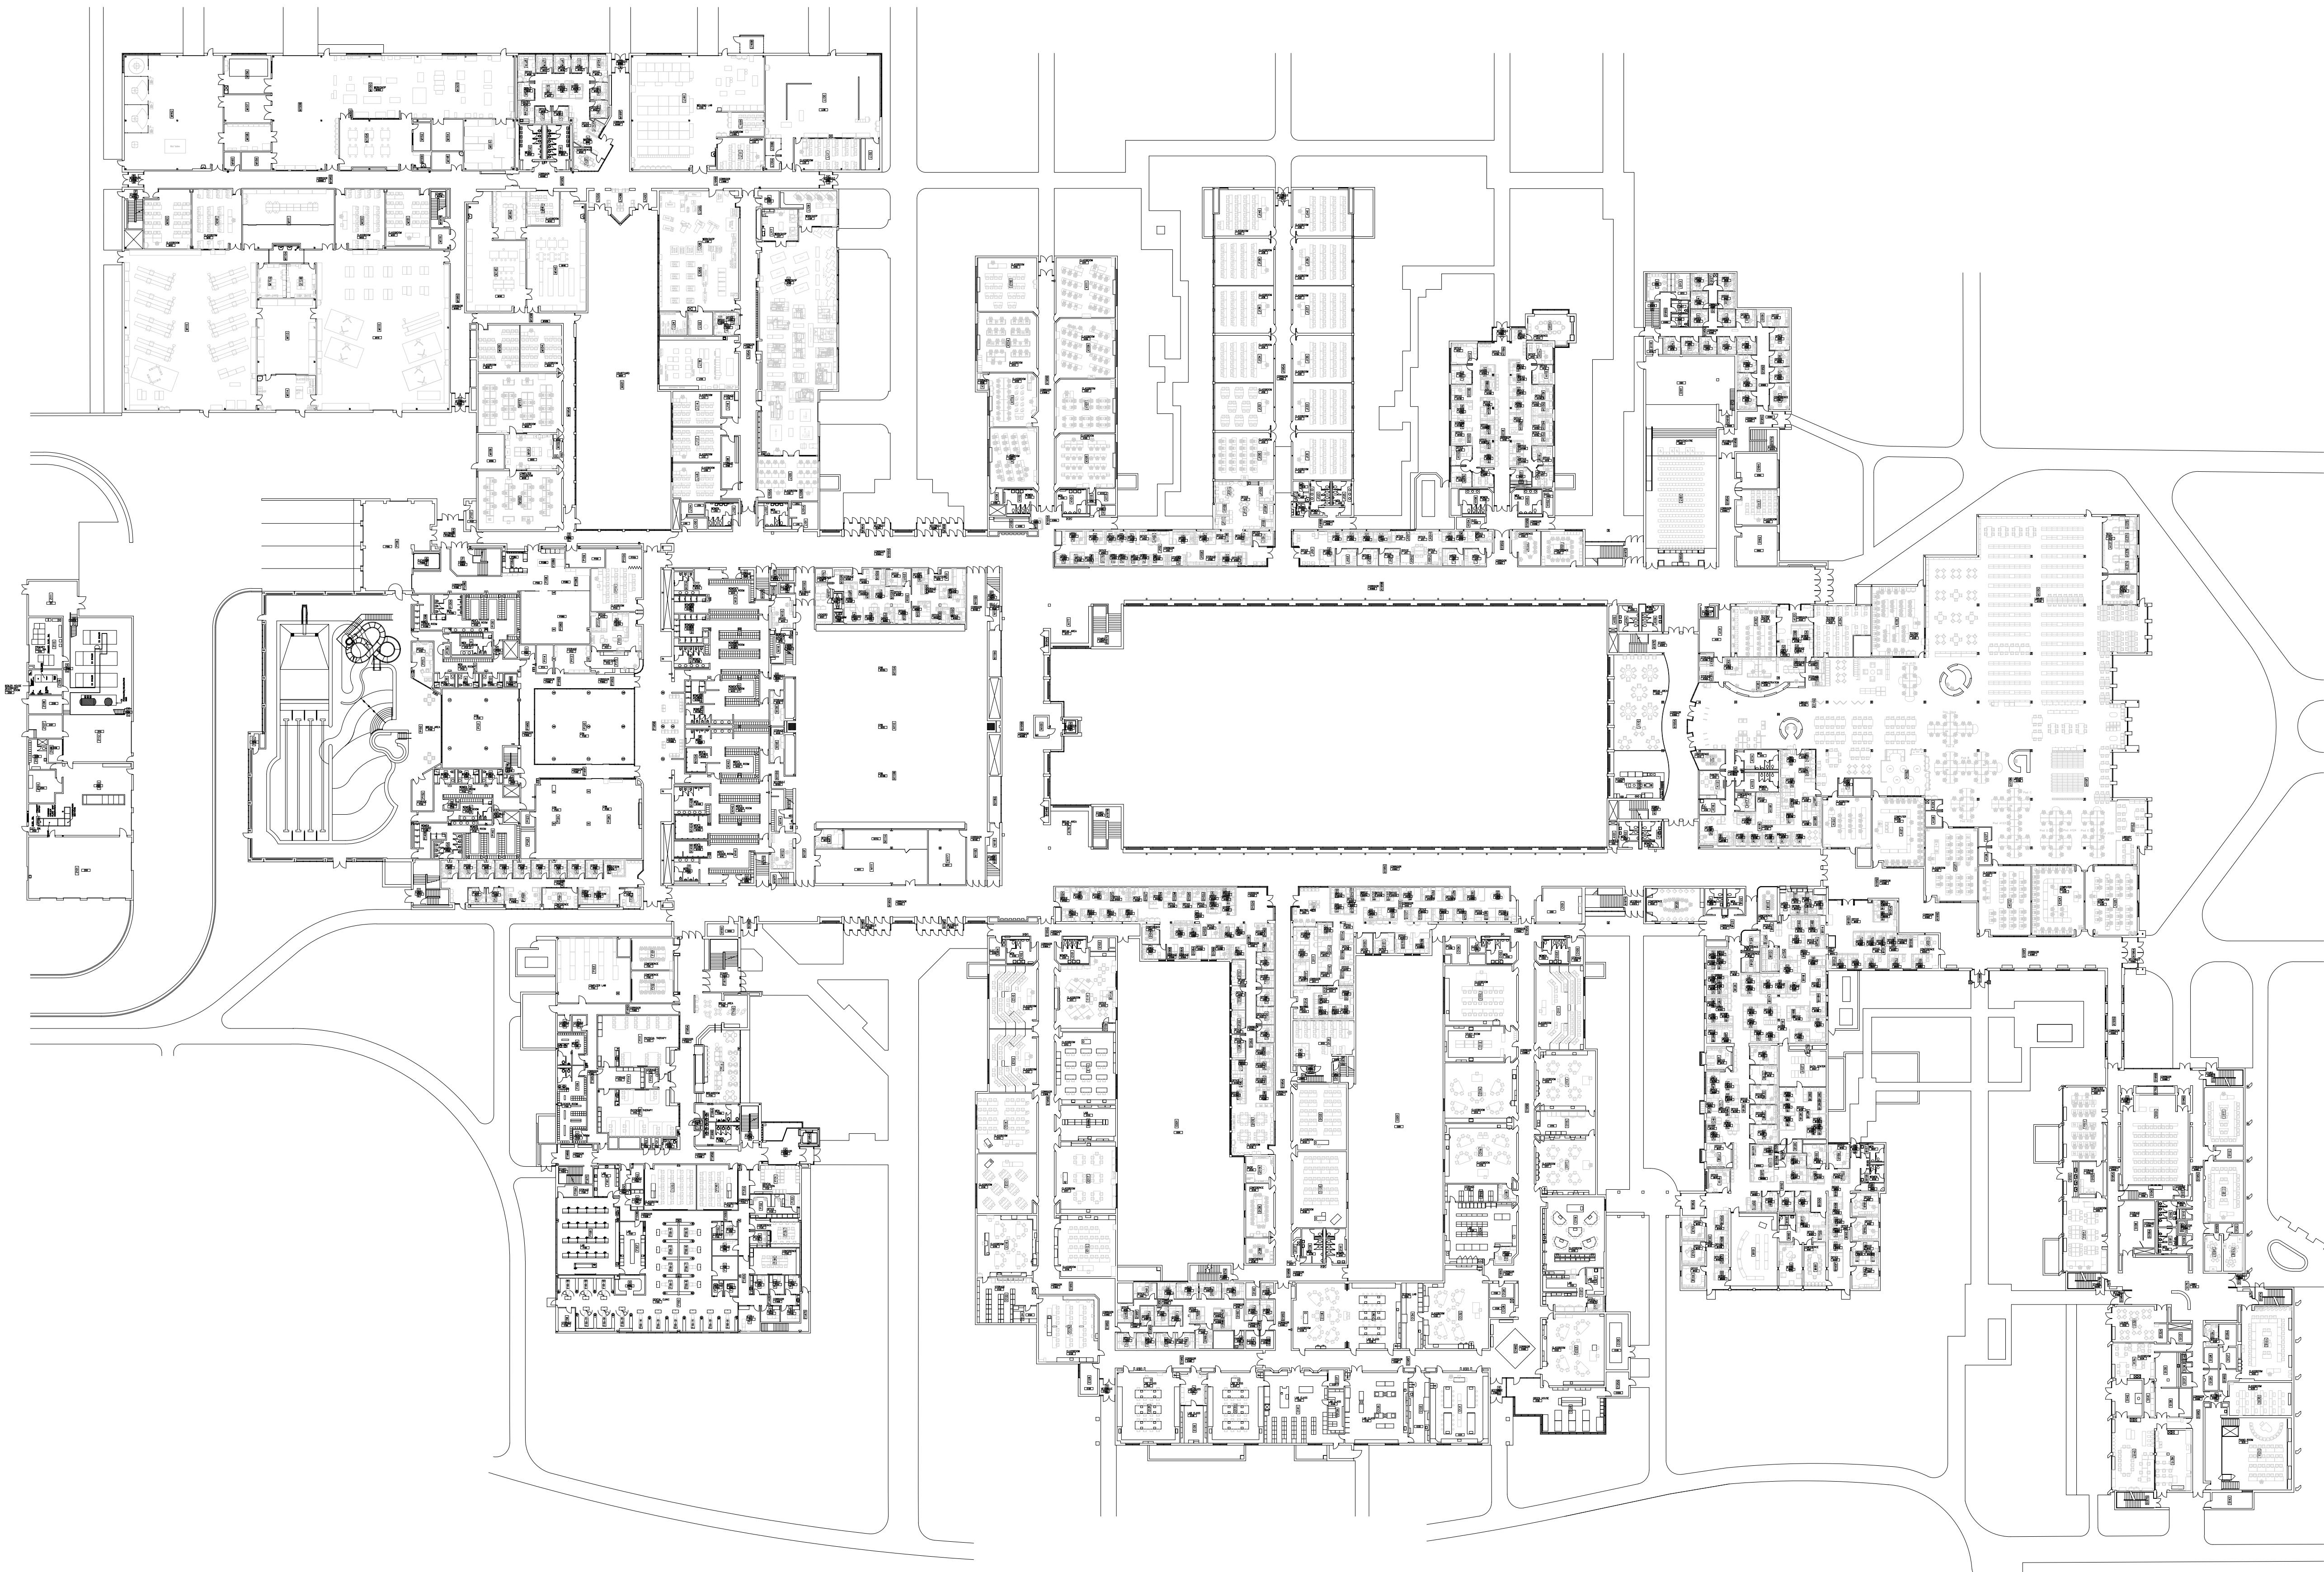
# FIRST FLOOR COMPOSITE EGRESS PLAN

## FIRST FLOOR COMPOSITE EGRESS PLAN

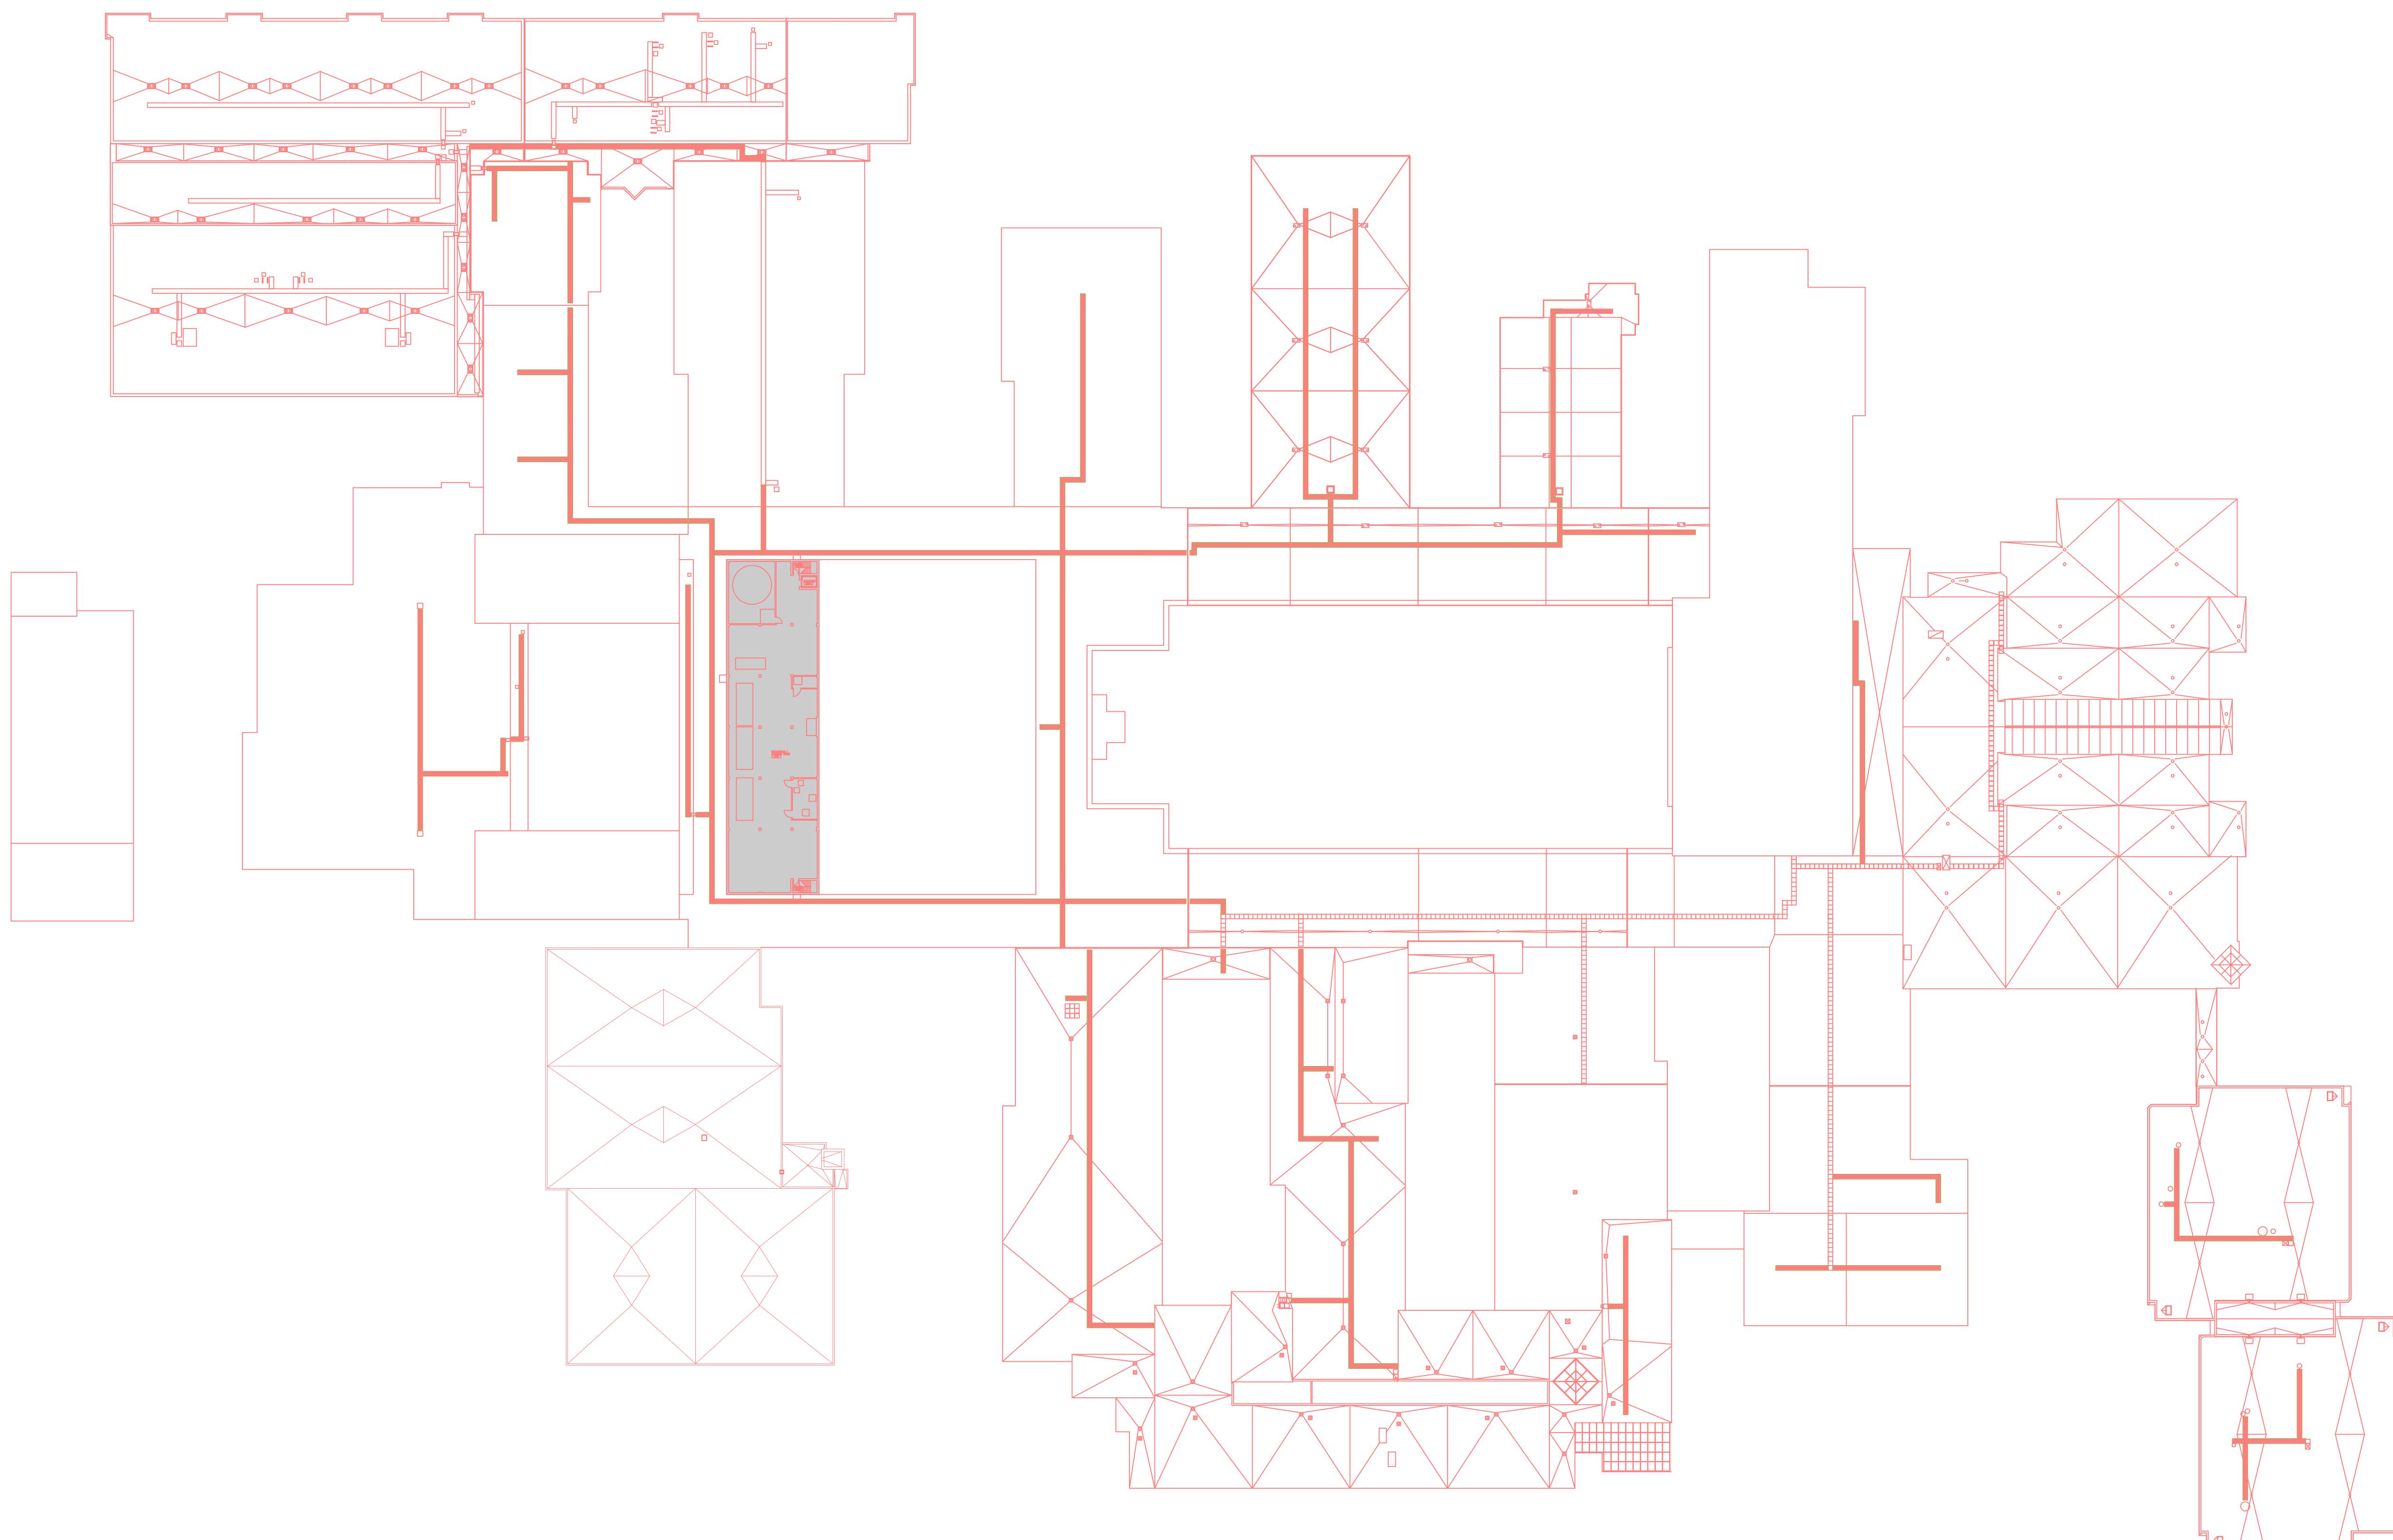
IGNER:	DA
SELLER:	DA
	ATW
	BJR
DFILE:	20-0501-A-104.DWG
JECT No.	20-0501.00
ET TITLE	MAIN CAMPUS THIRD FLOOR COMPOSITE PLAN
ET NUMBER

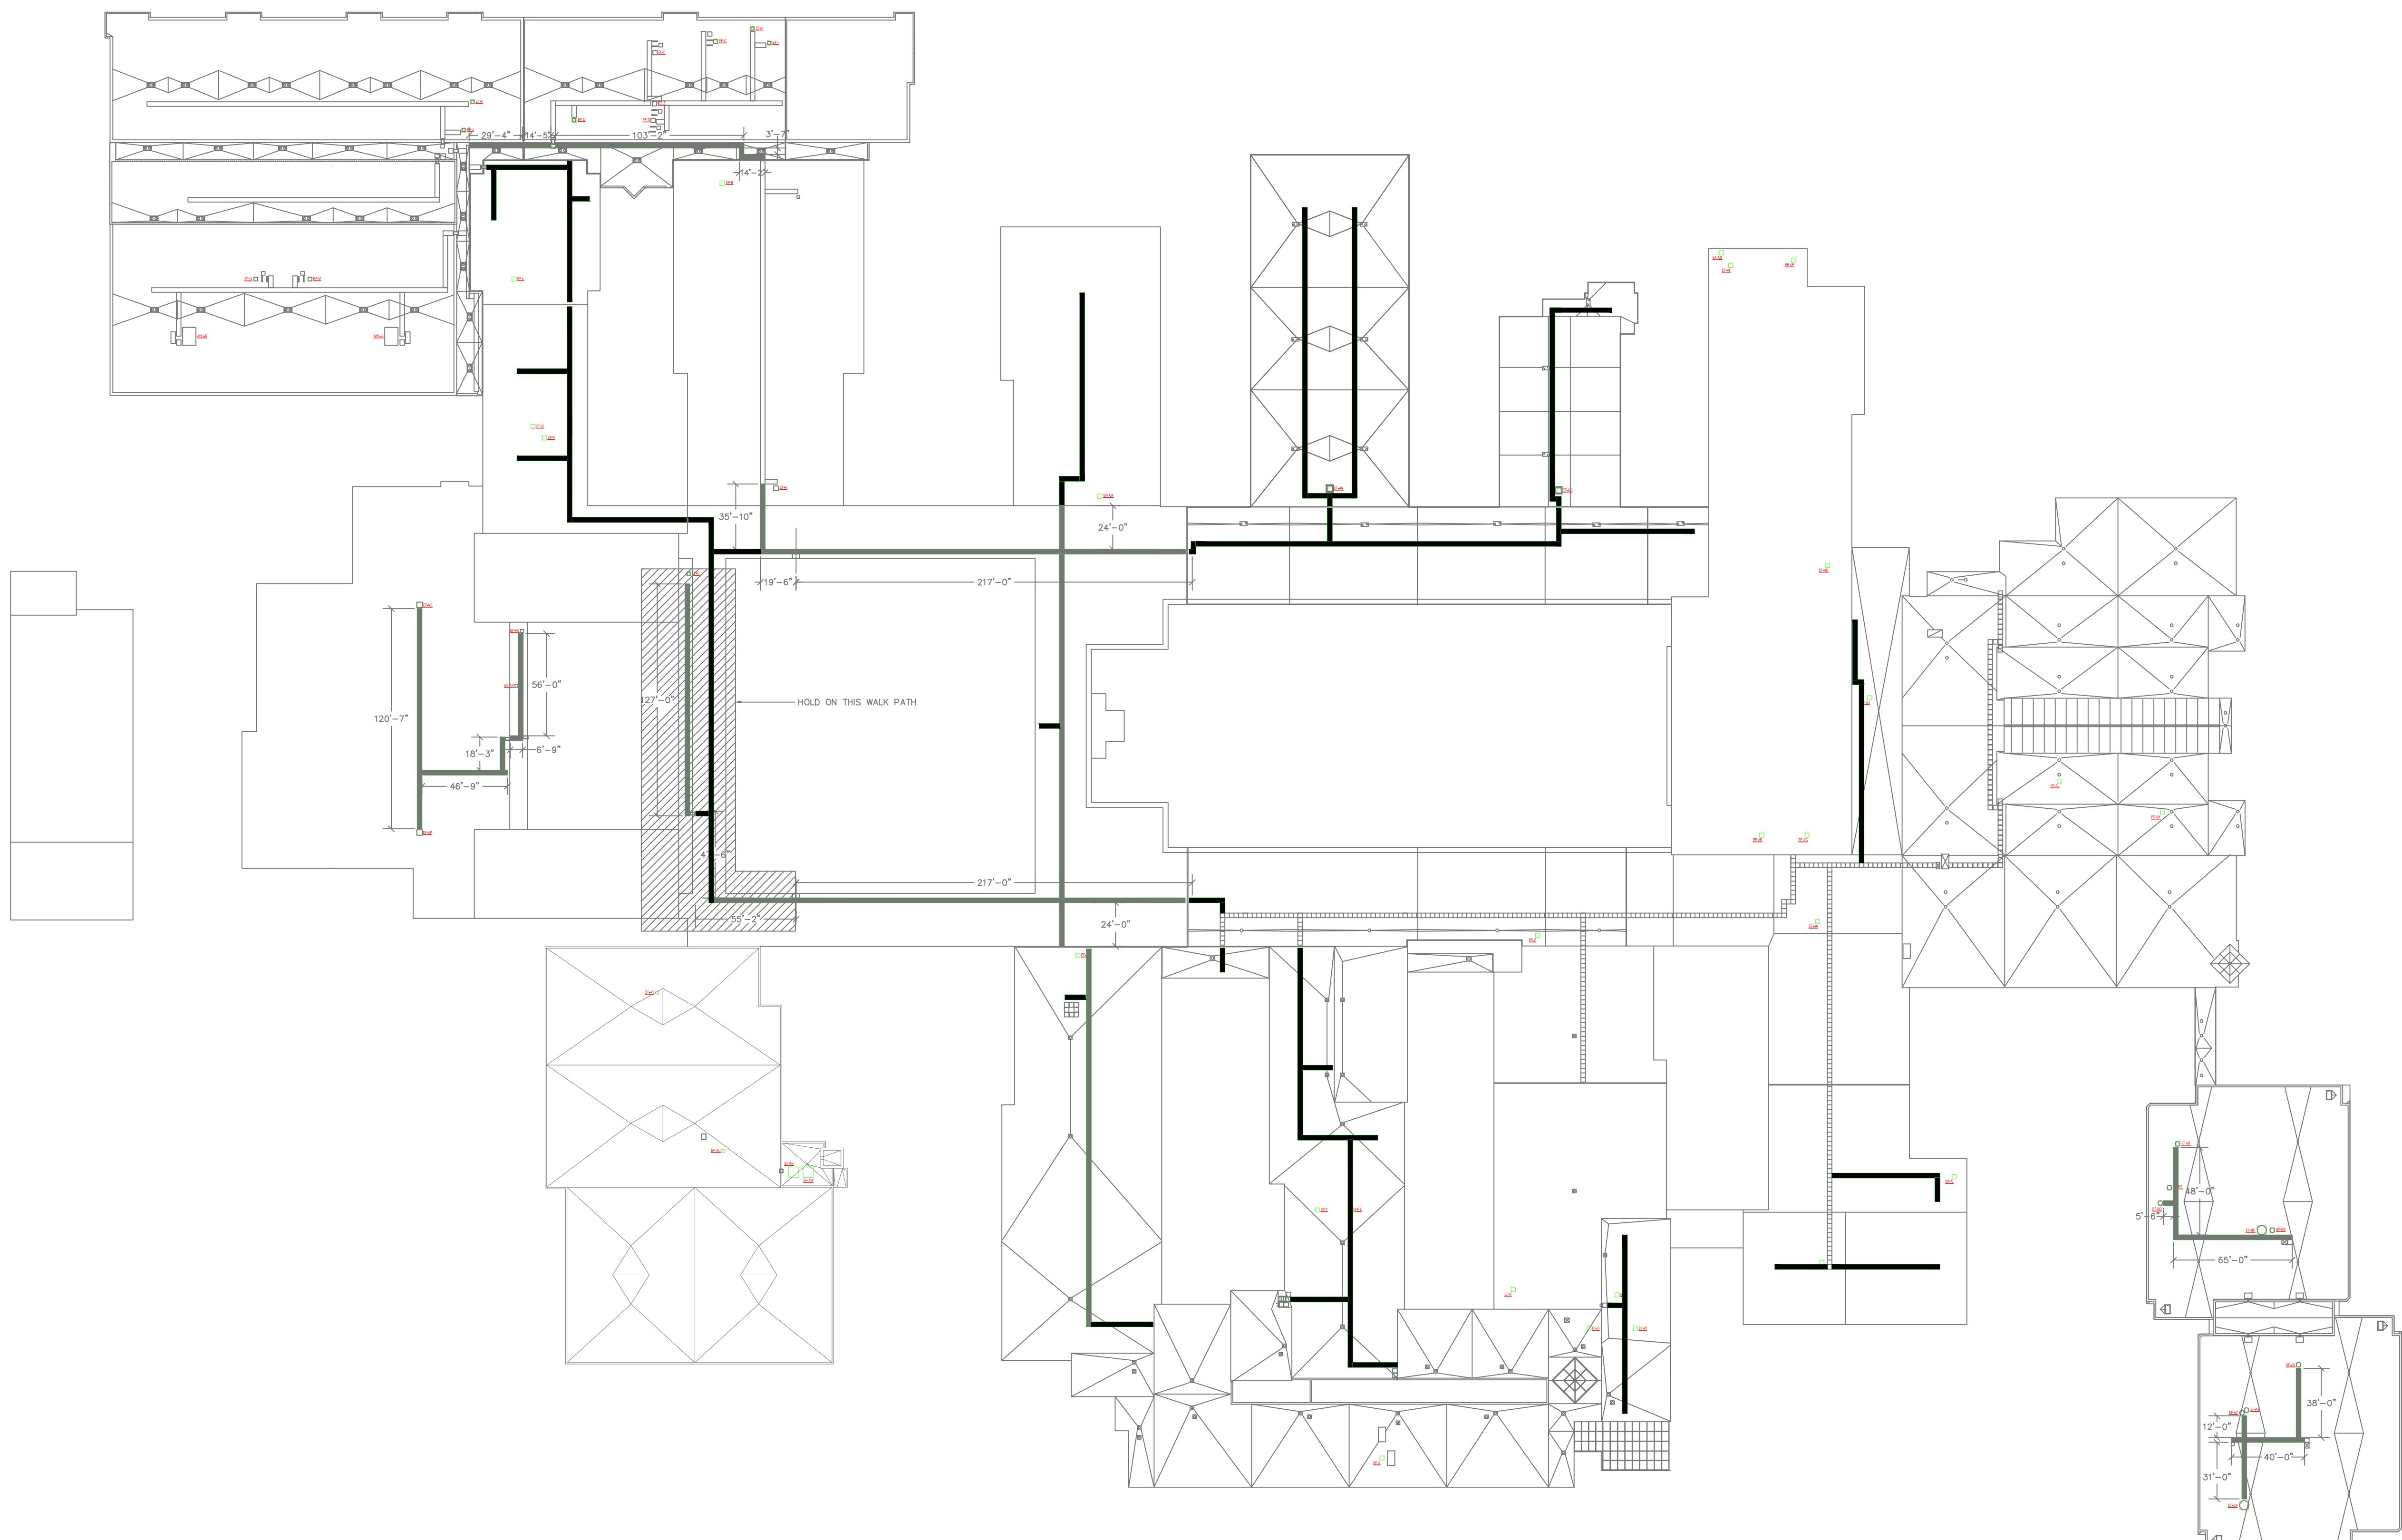
ROOF MECHANICAL PLAN

NORTH  MECHANICAL FLOOR  
SCALE: 1" = 50'
