# **DELTA COLLEGE**

## **FACILITIES CONDITION ASSESSMENT**

DSD Project No. 20-0501

UNIVERSITY CENTER, MICHIGAN

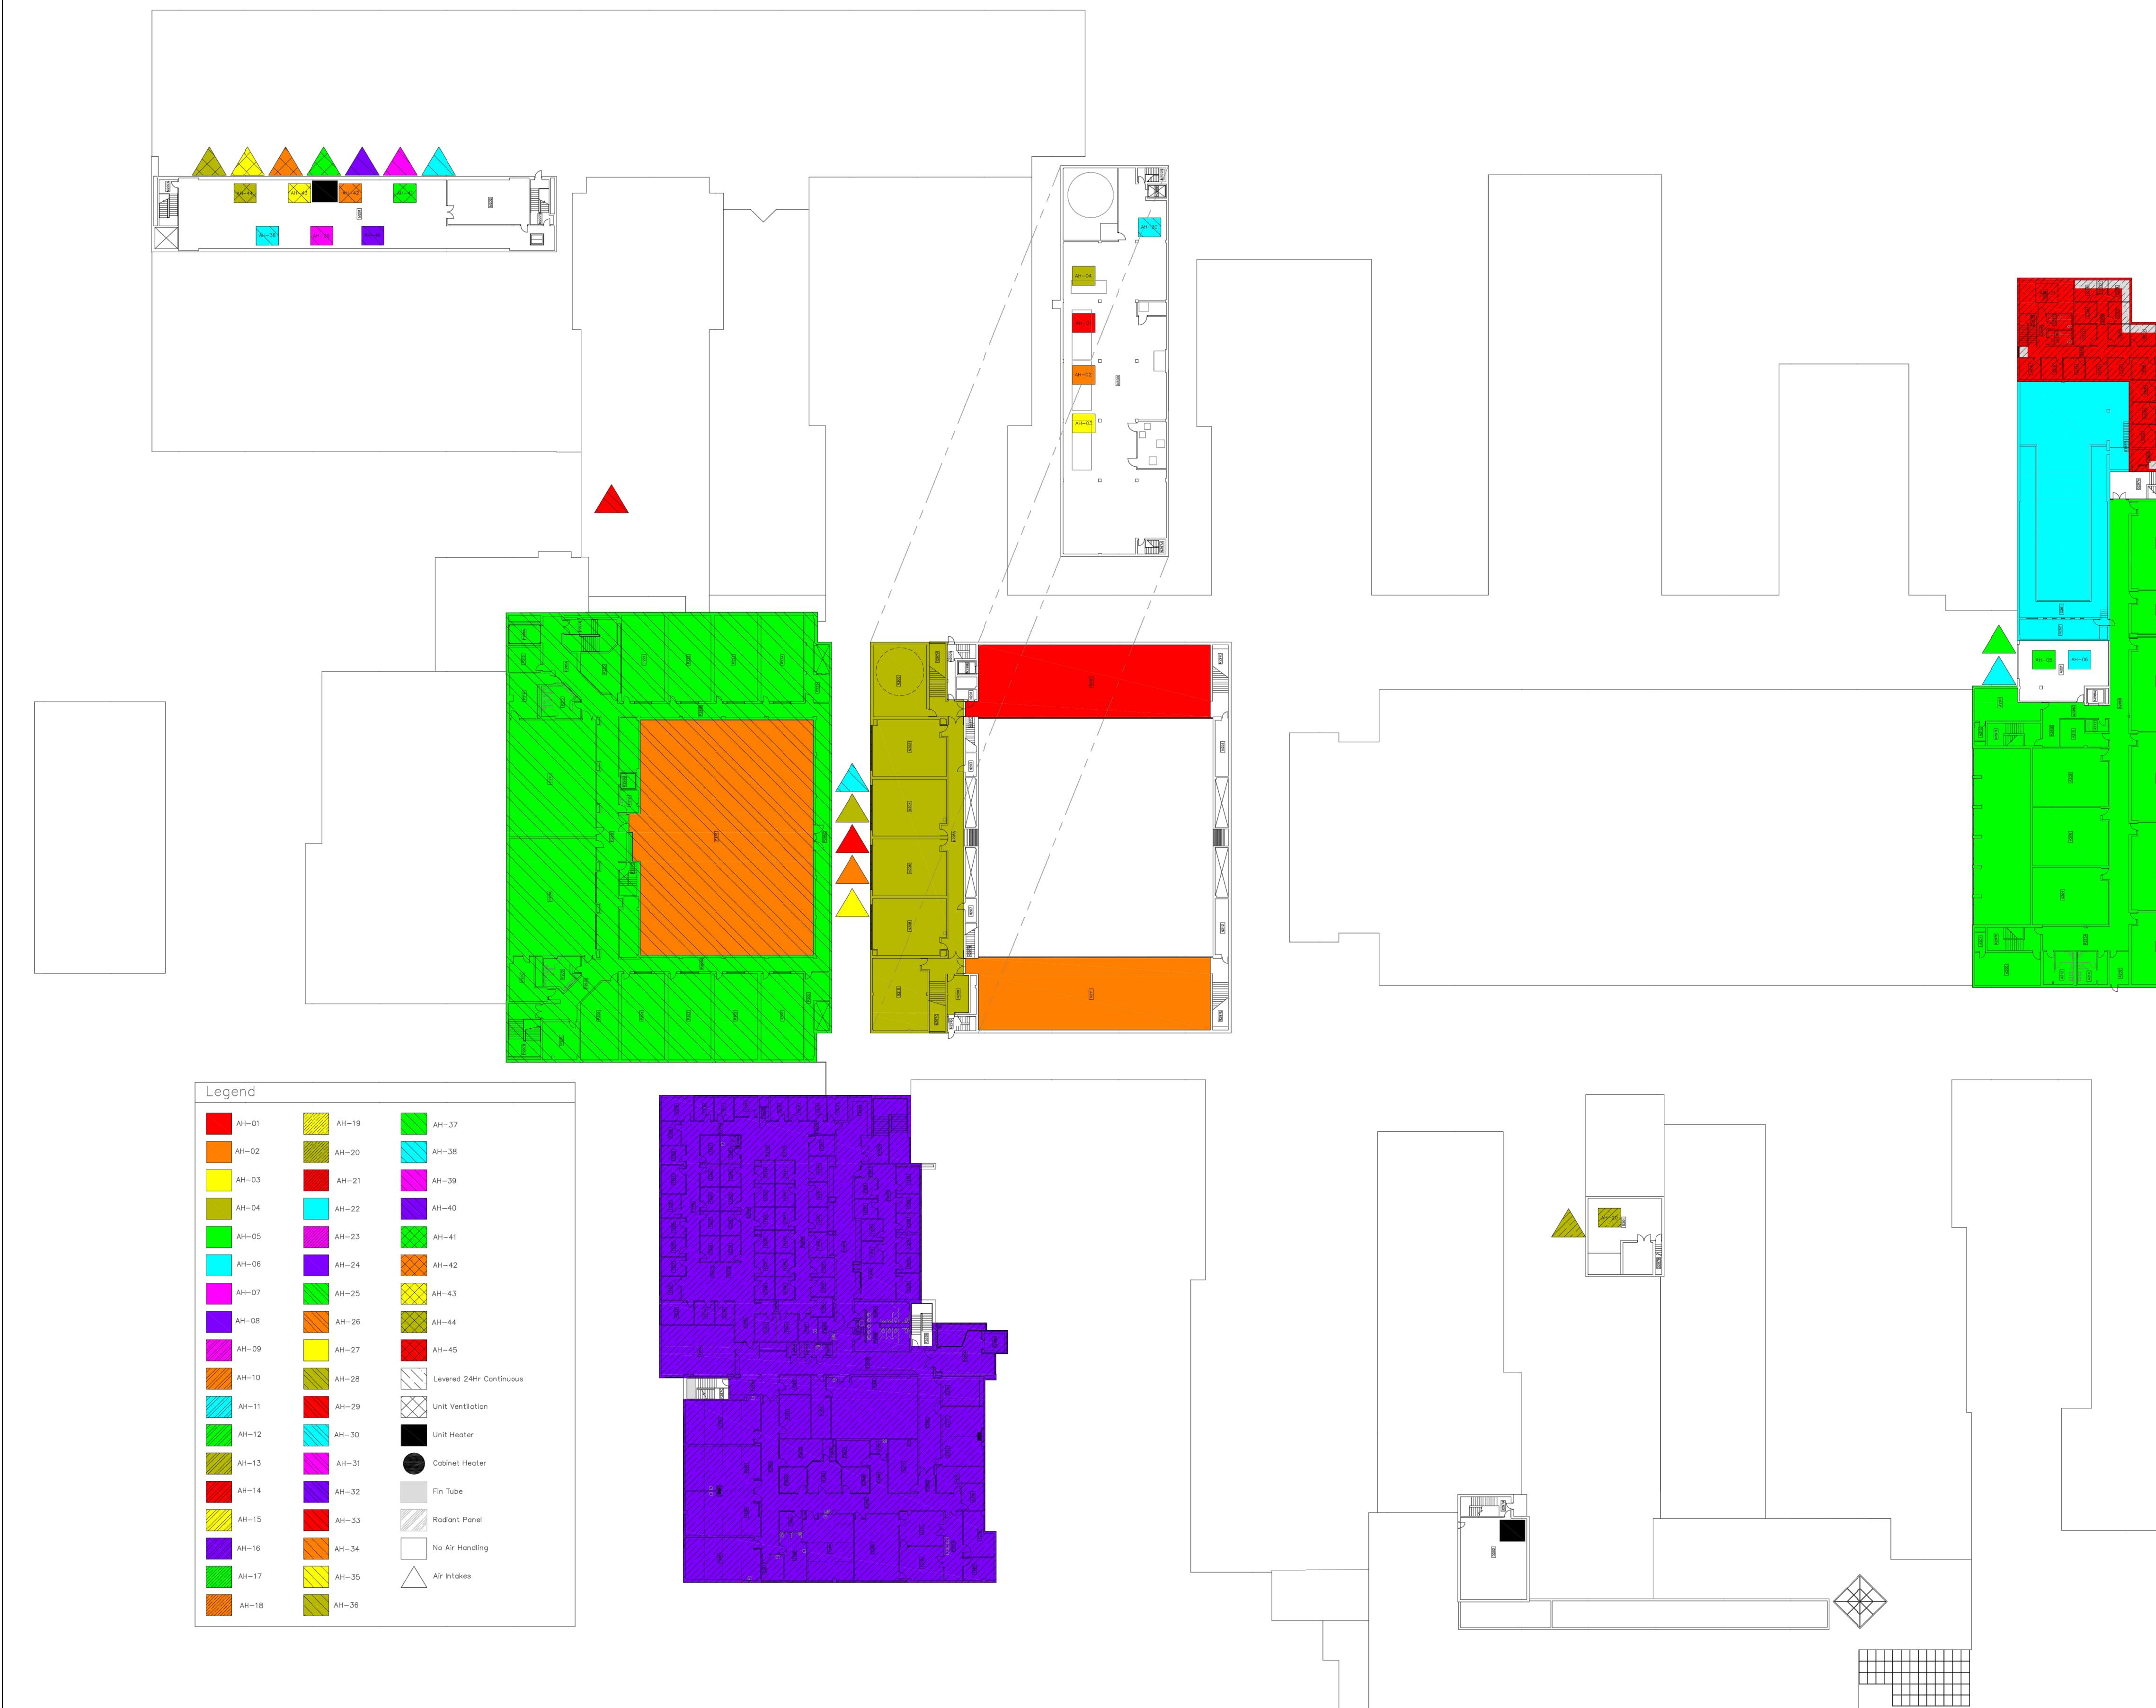
Second Floor – Heating & Cooling

DESIGNER:	KLE
MODELER:	JDL
PM:	ATW
PIC:	BUR
ACADFILE:	202001A402.DWG
PROJECT No:	20-0501.00
SHEET TITLE	SECOND FLOOR AIR HANDLING UNIT ZONE PLAN
SHEET NUMBER	M-602

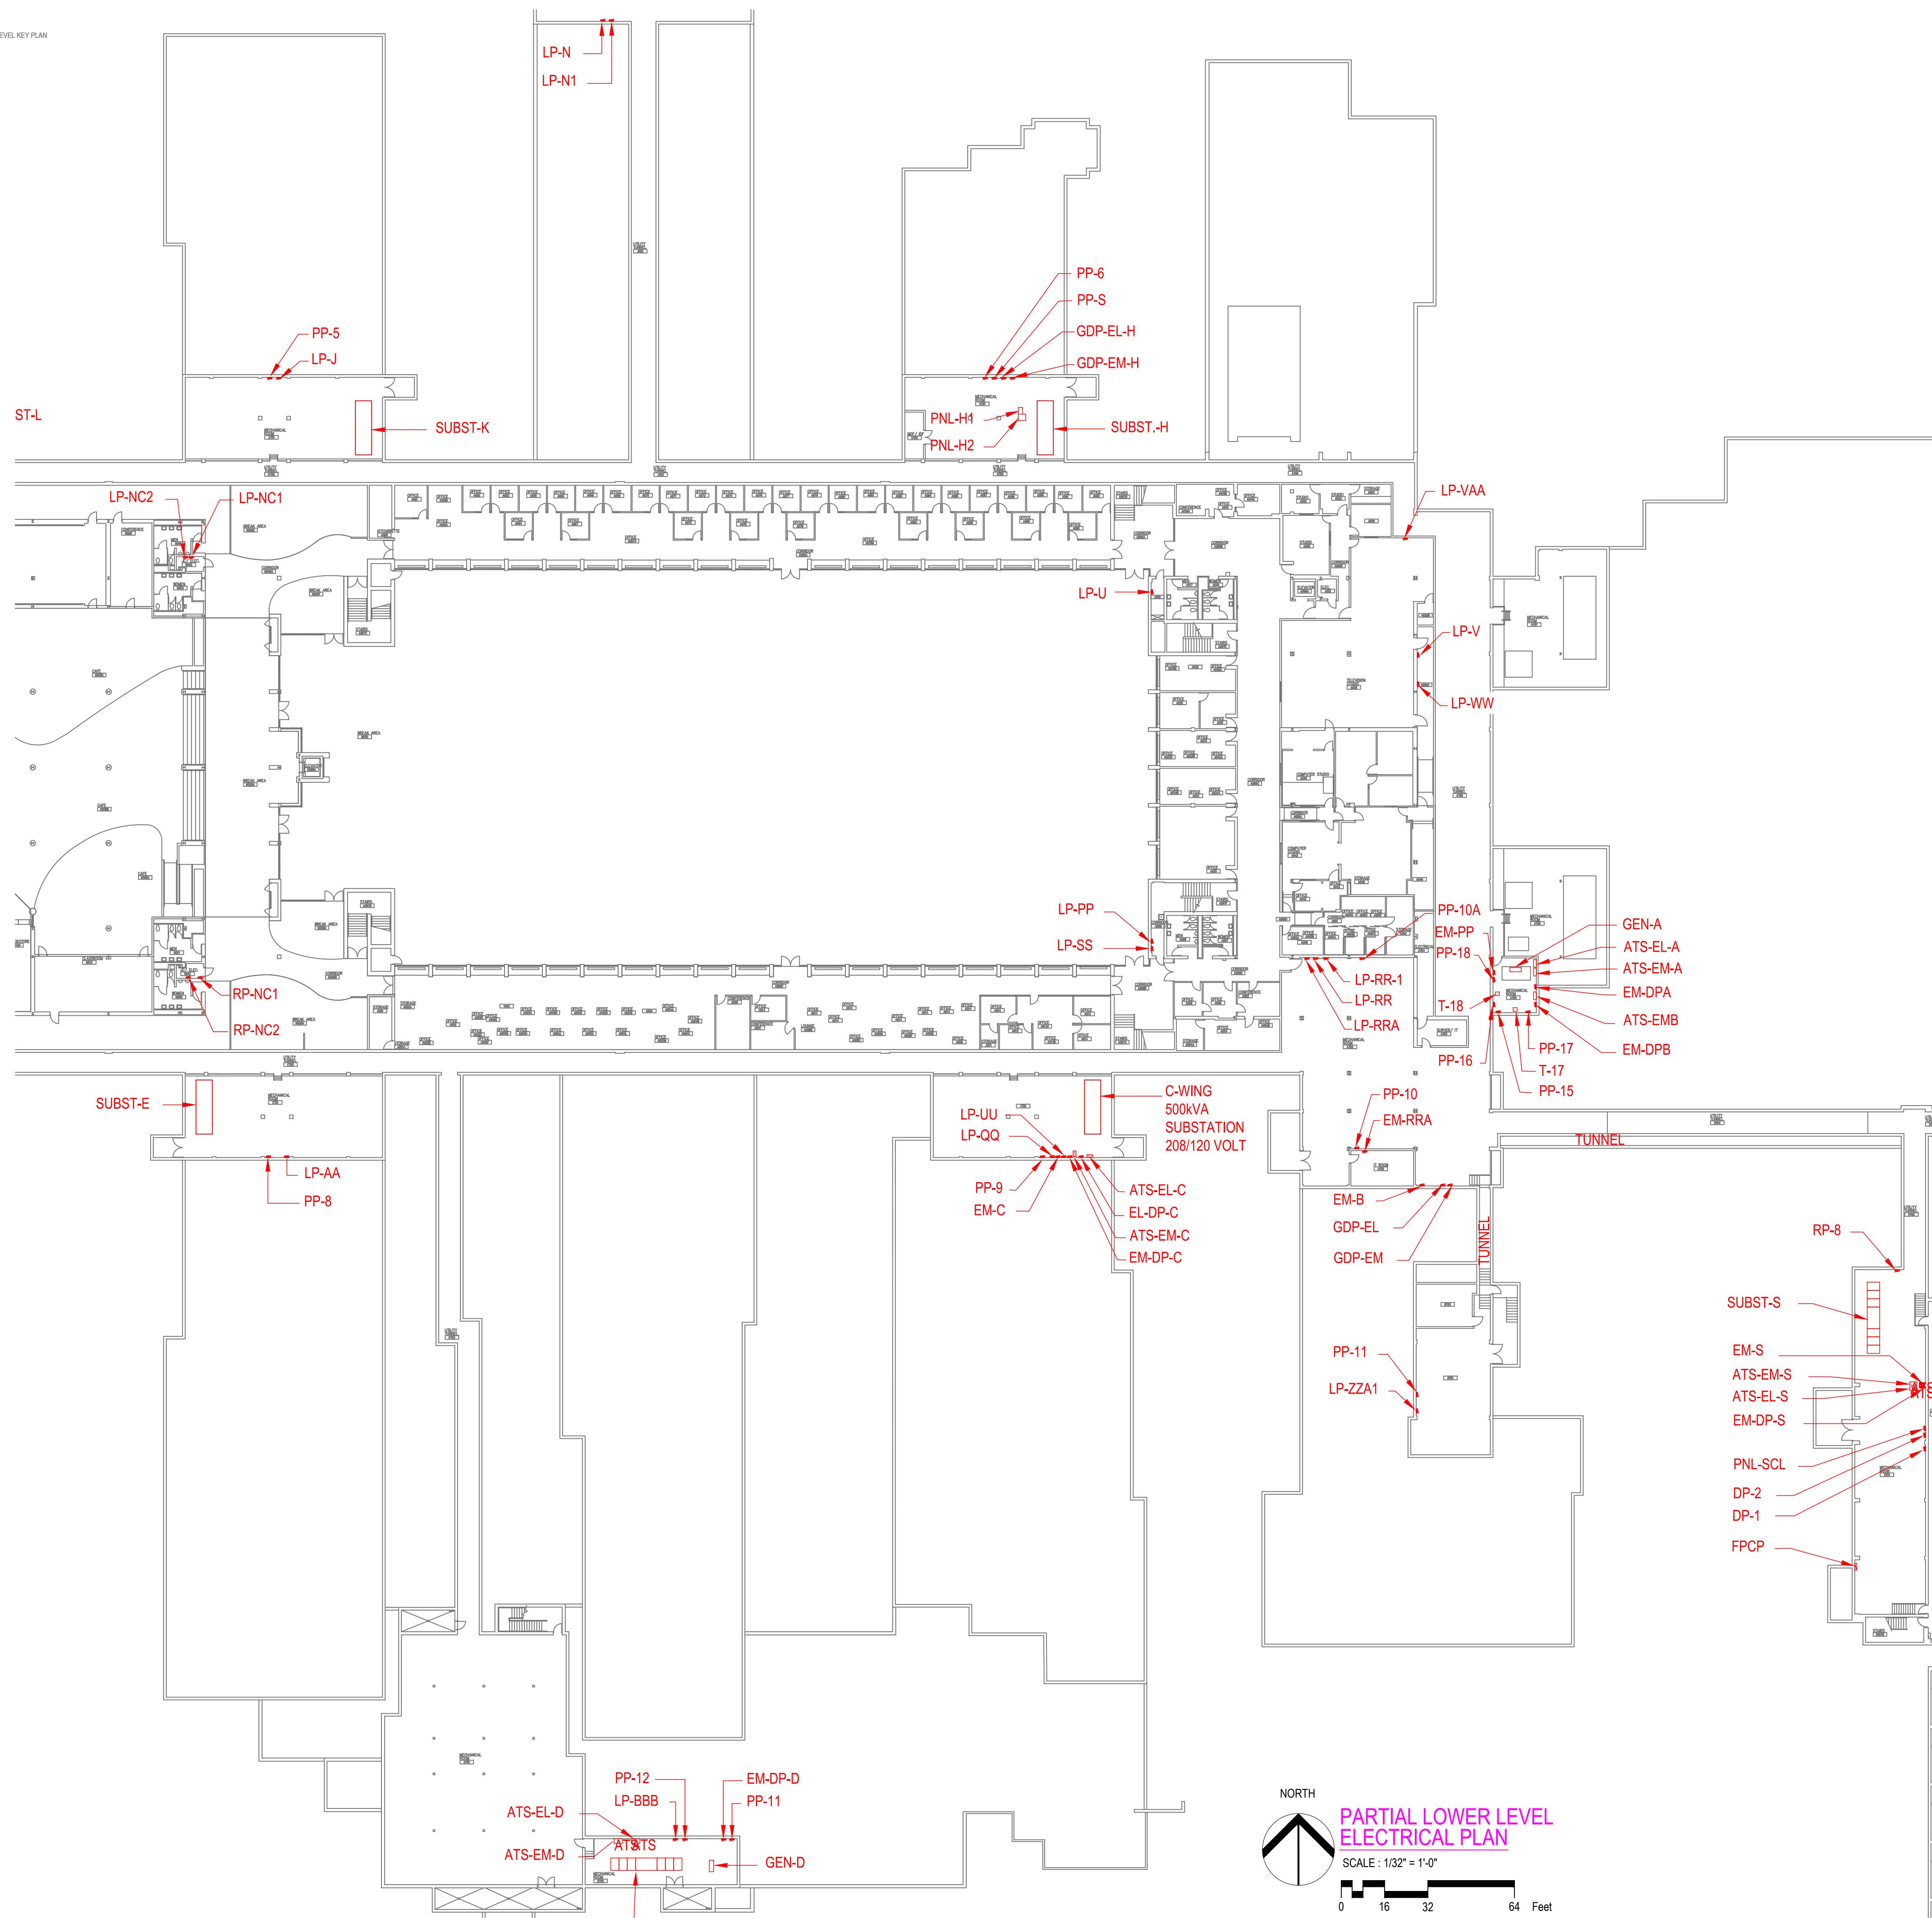
# PARTIAL LOWER LEVEL ELECTRICAL PLAN

DESIGNER:	TBR
MODELLER:	DOA
PM:	ATW
PIC:	BUR
ACADFILE:	20-0501-00
PROJECT No:	20-0501.00
SHEET TITLE:	MAIN CAMPUS LOWER LEVEL ELECTRICAL PLAN
SHEET NUMBER:	E-102

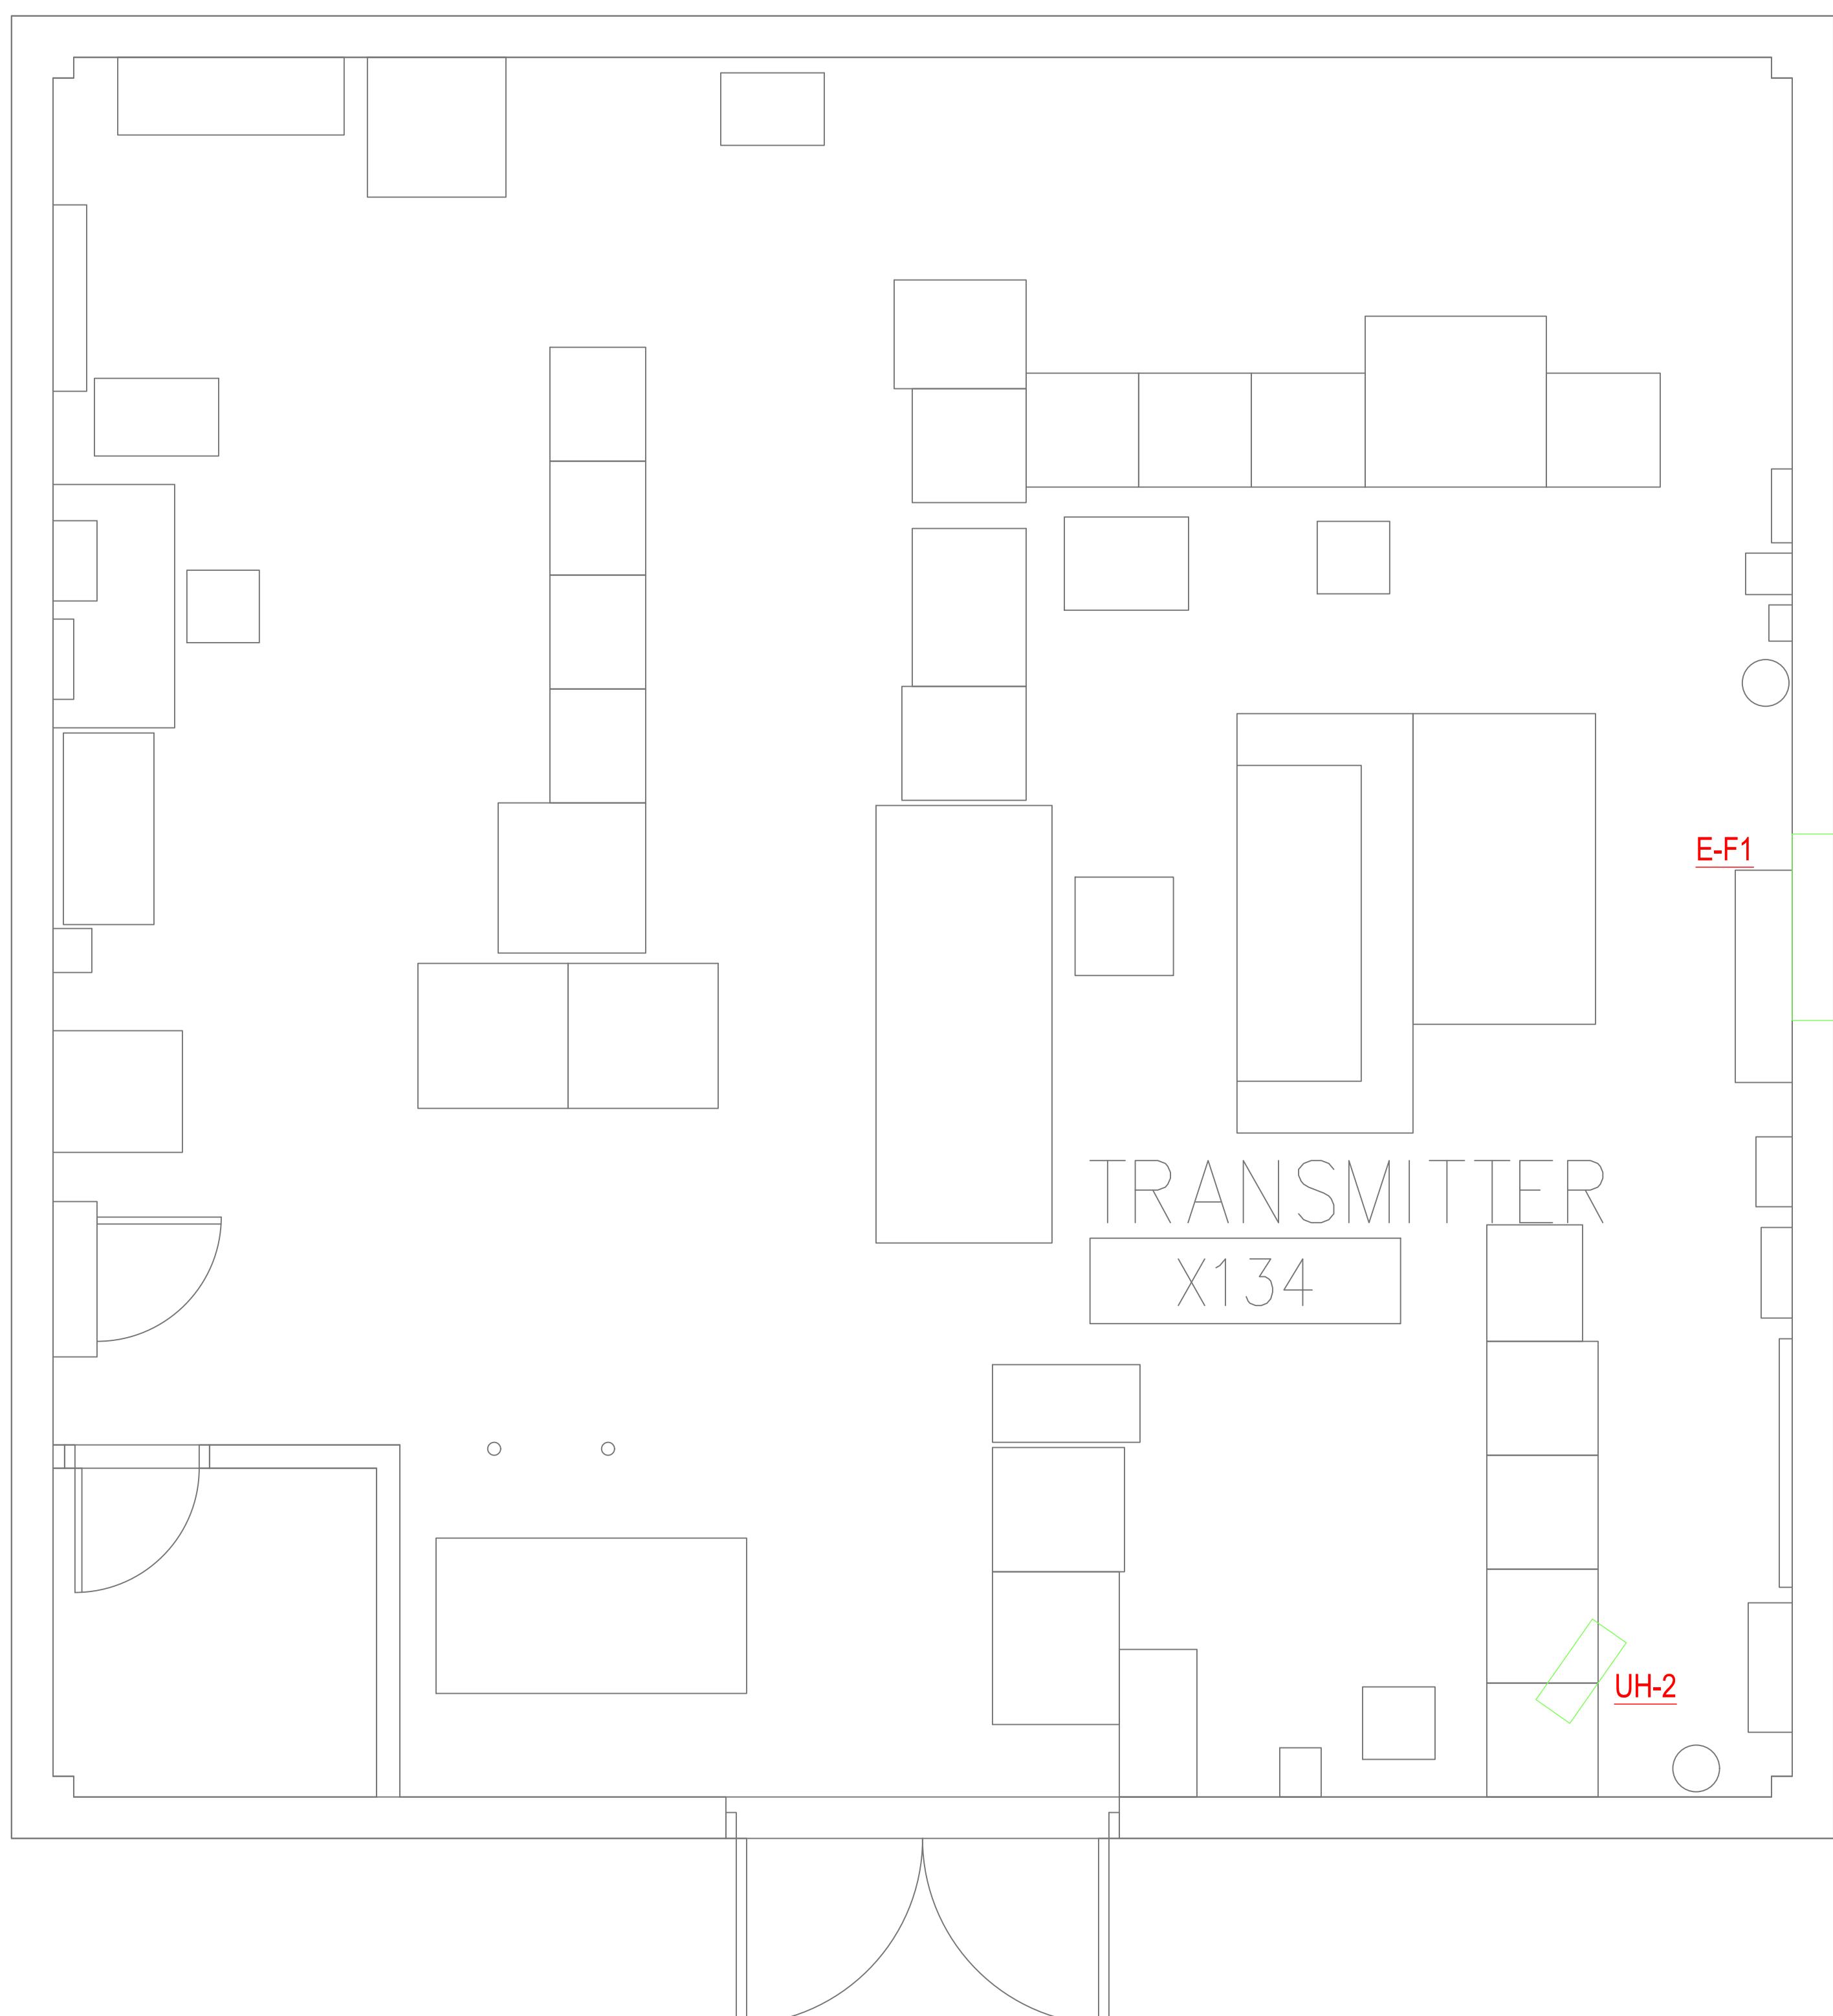
**FIRST FLOOR  
TRANSMITTER #2 MECHANICAL PLAN**

IGNER:	KLE
SELLER:	EKS
	ATW
	BJR
DFILE:	20-0501-M-101.DWG
JECT No.	20-0501.00
ET TITLE	
SERVICE BUILDINGS	
FIRST FLOOR	
MECHANICAL PLAN	
ET NUMBER	
M-101

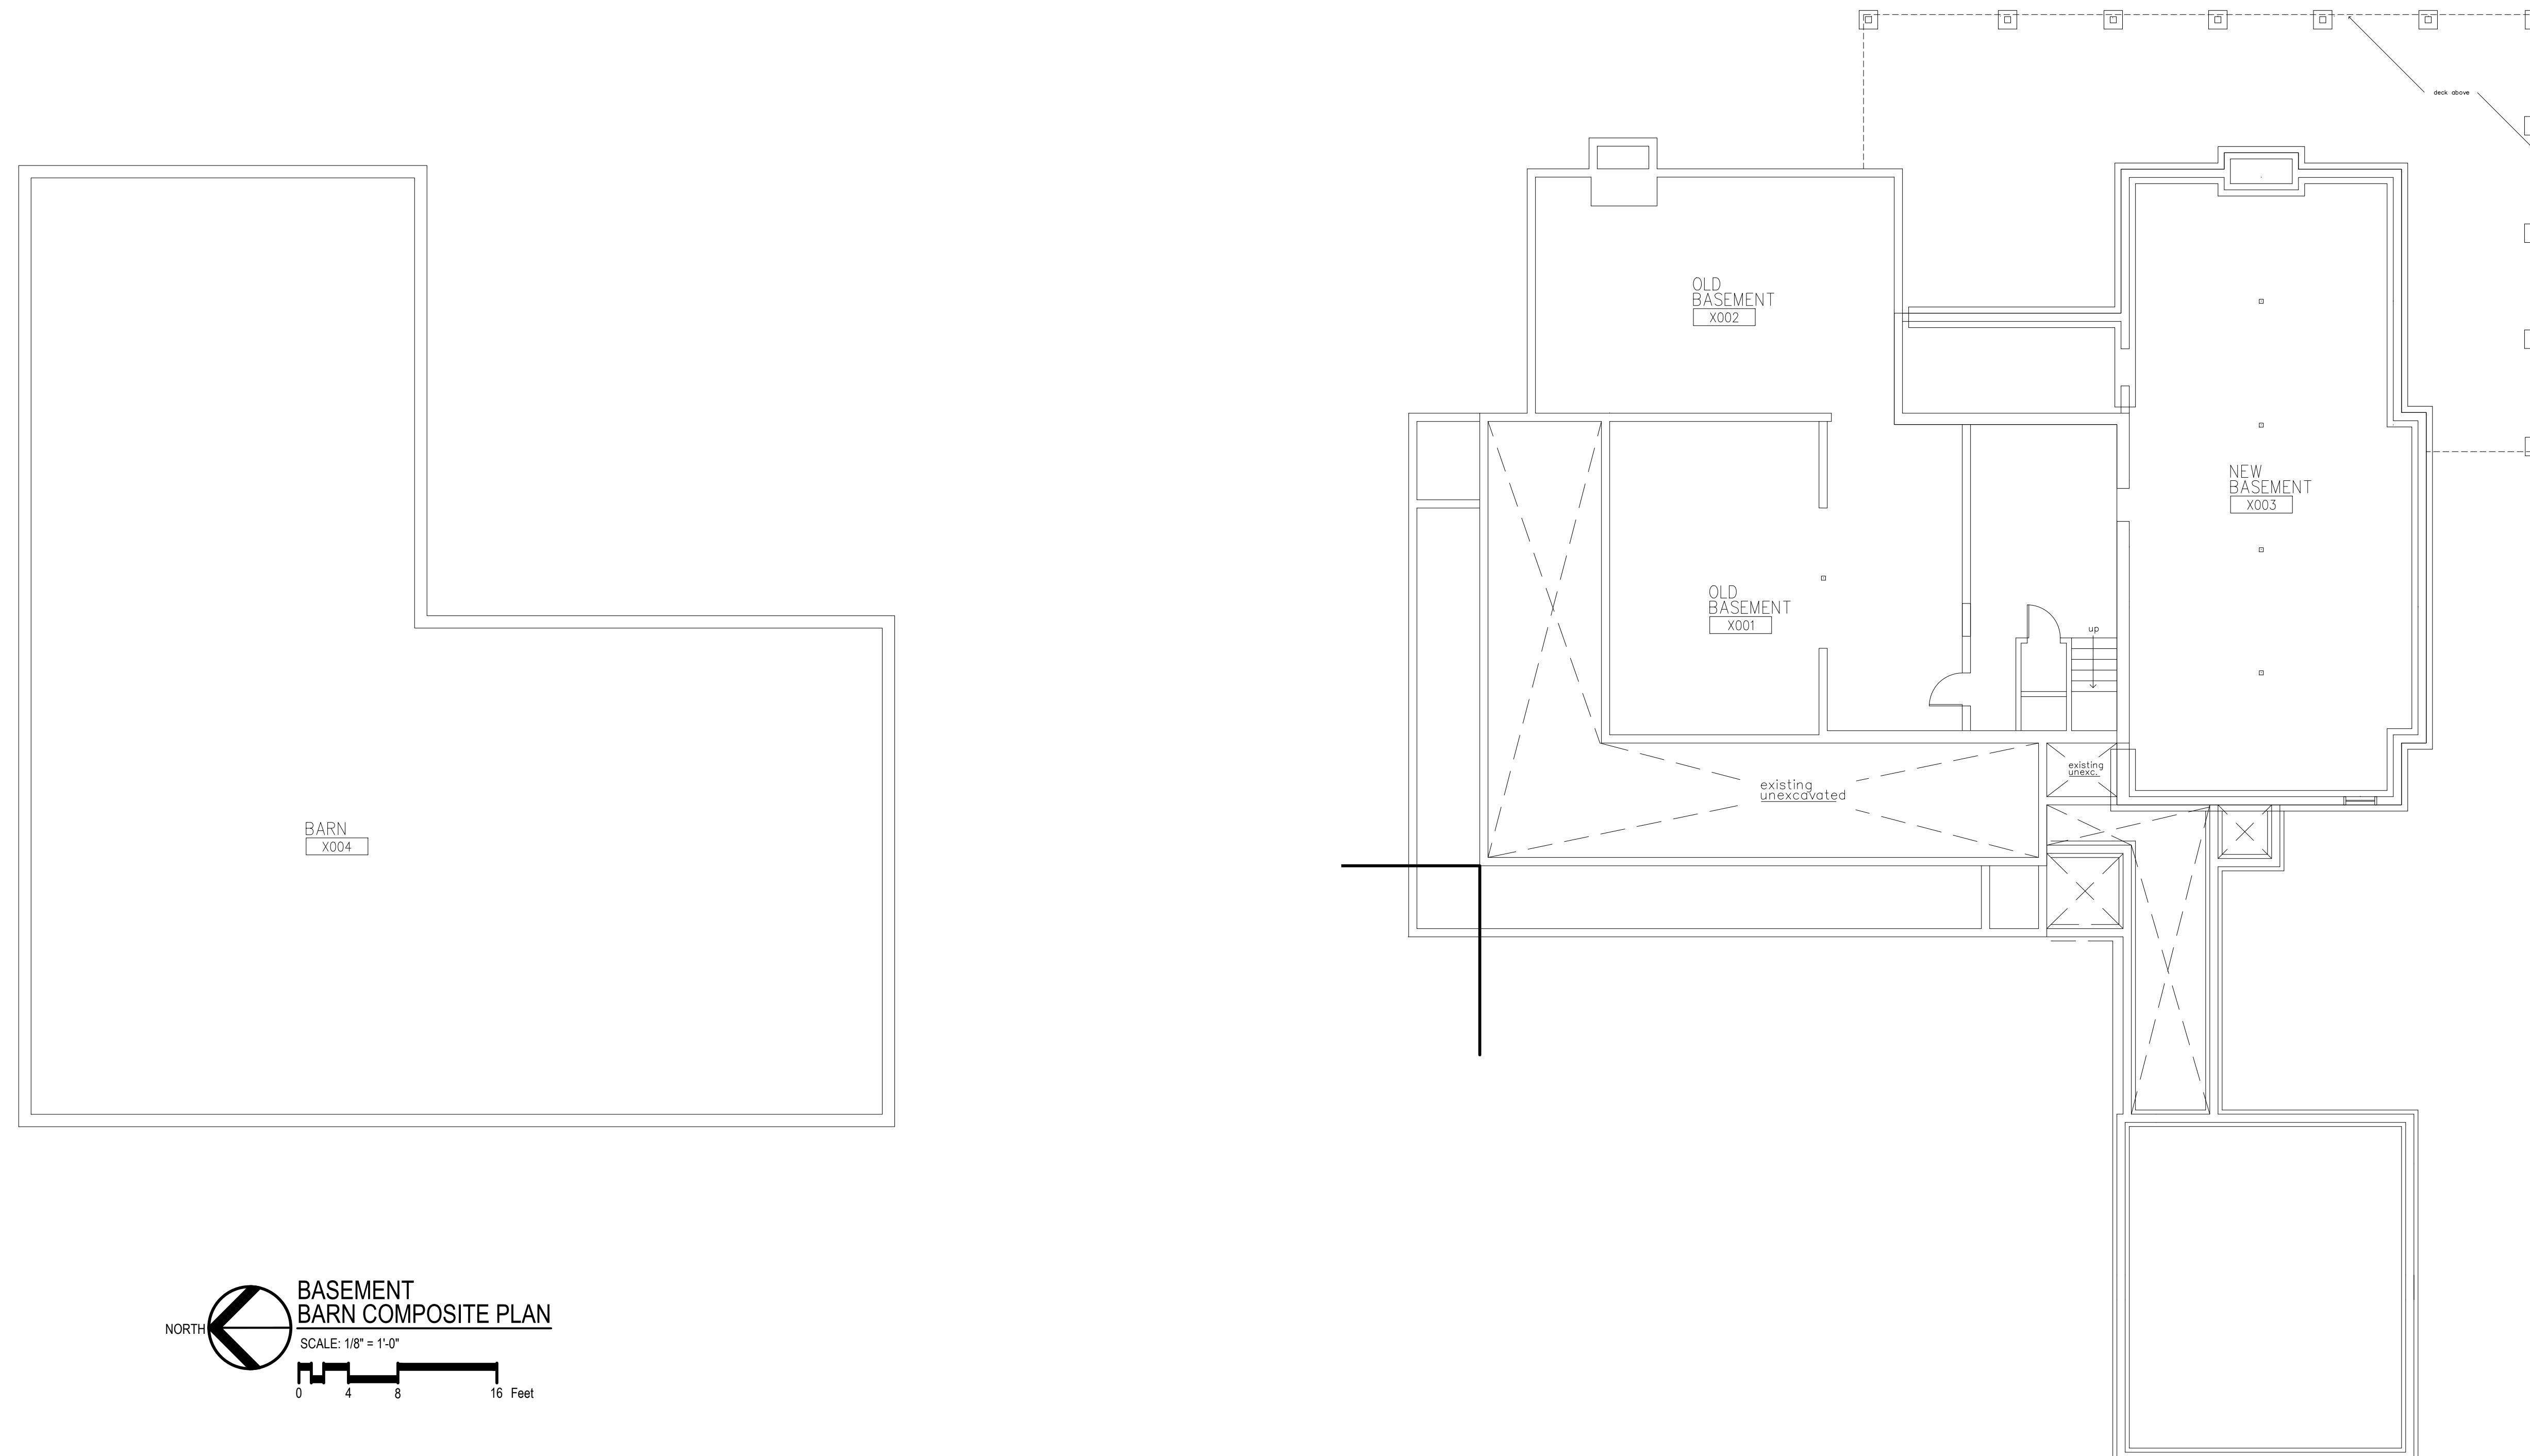
**BASEMENT BARN COMPOSITE PLAN**

DESIGNER:	REW
MODELLER:	EKS
PM:	ATW
PIC:	BJR
ACADFILE:	20-0501-A-102.DWG
PROJECT No.	20-0501.00
SHEET TITLE	FARM HOUSE & BUILDINGS COMPOSITE BASEMENT ARCHITECTURAL PLAN
SHEET NUMBER	A-102

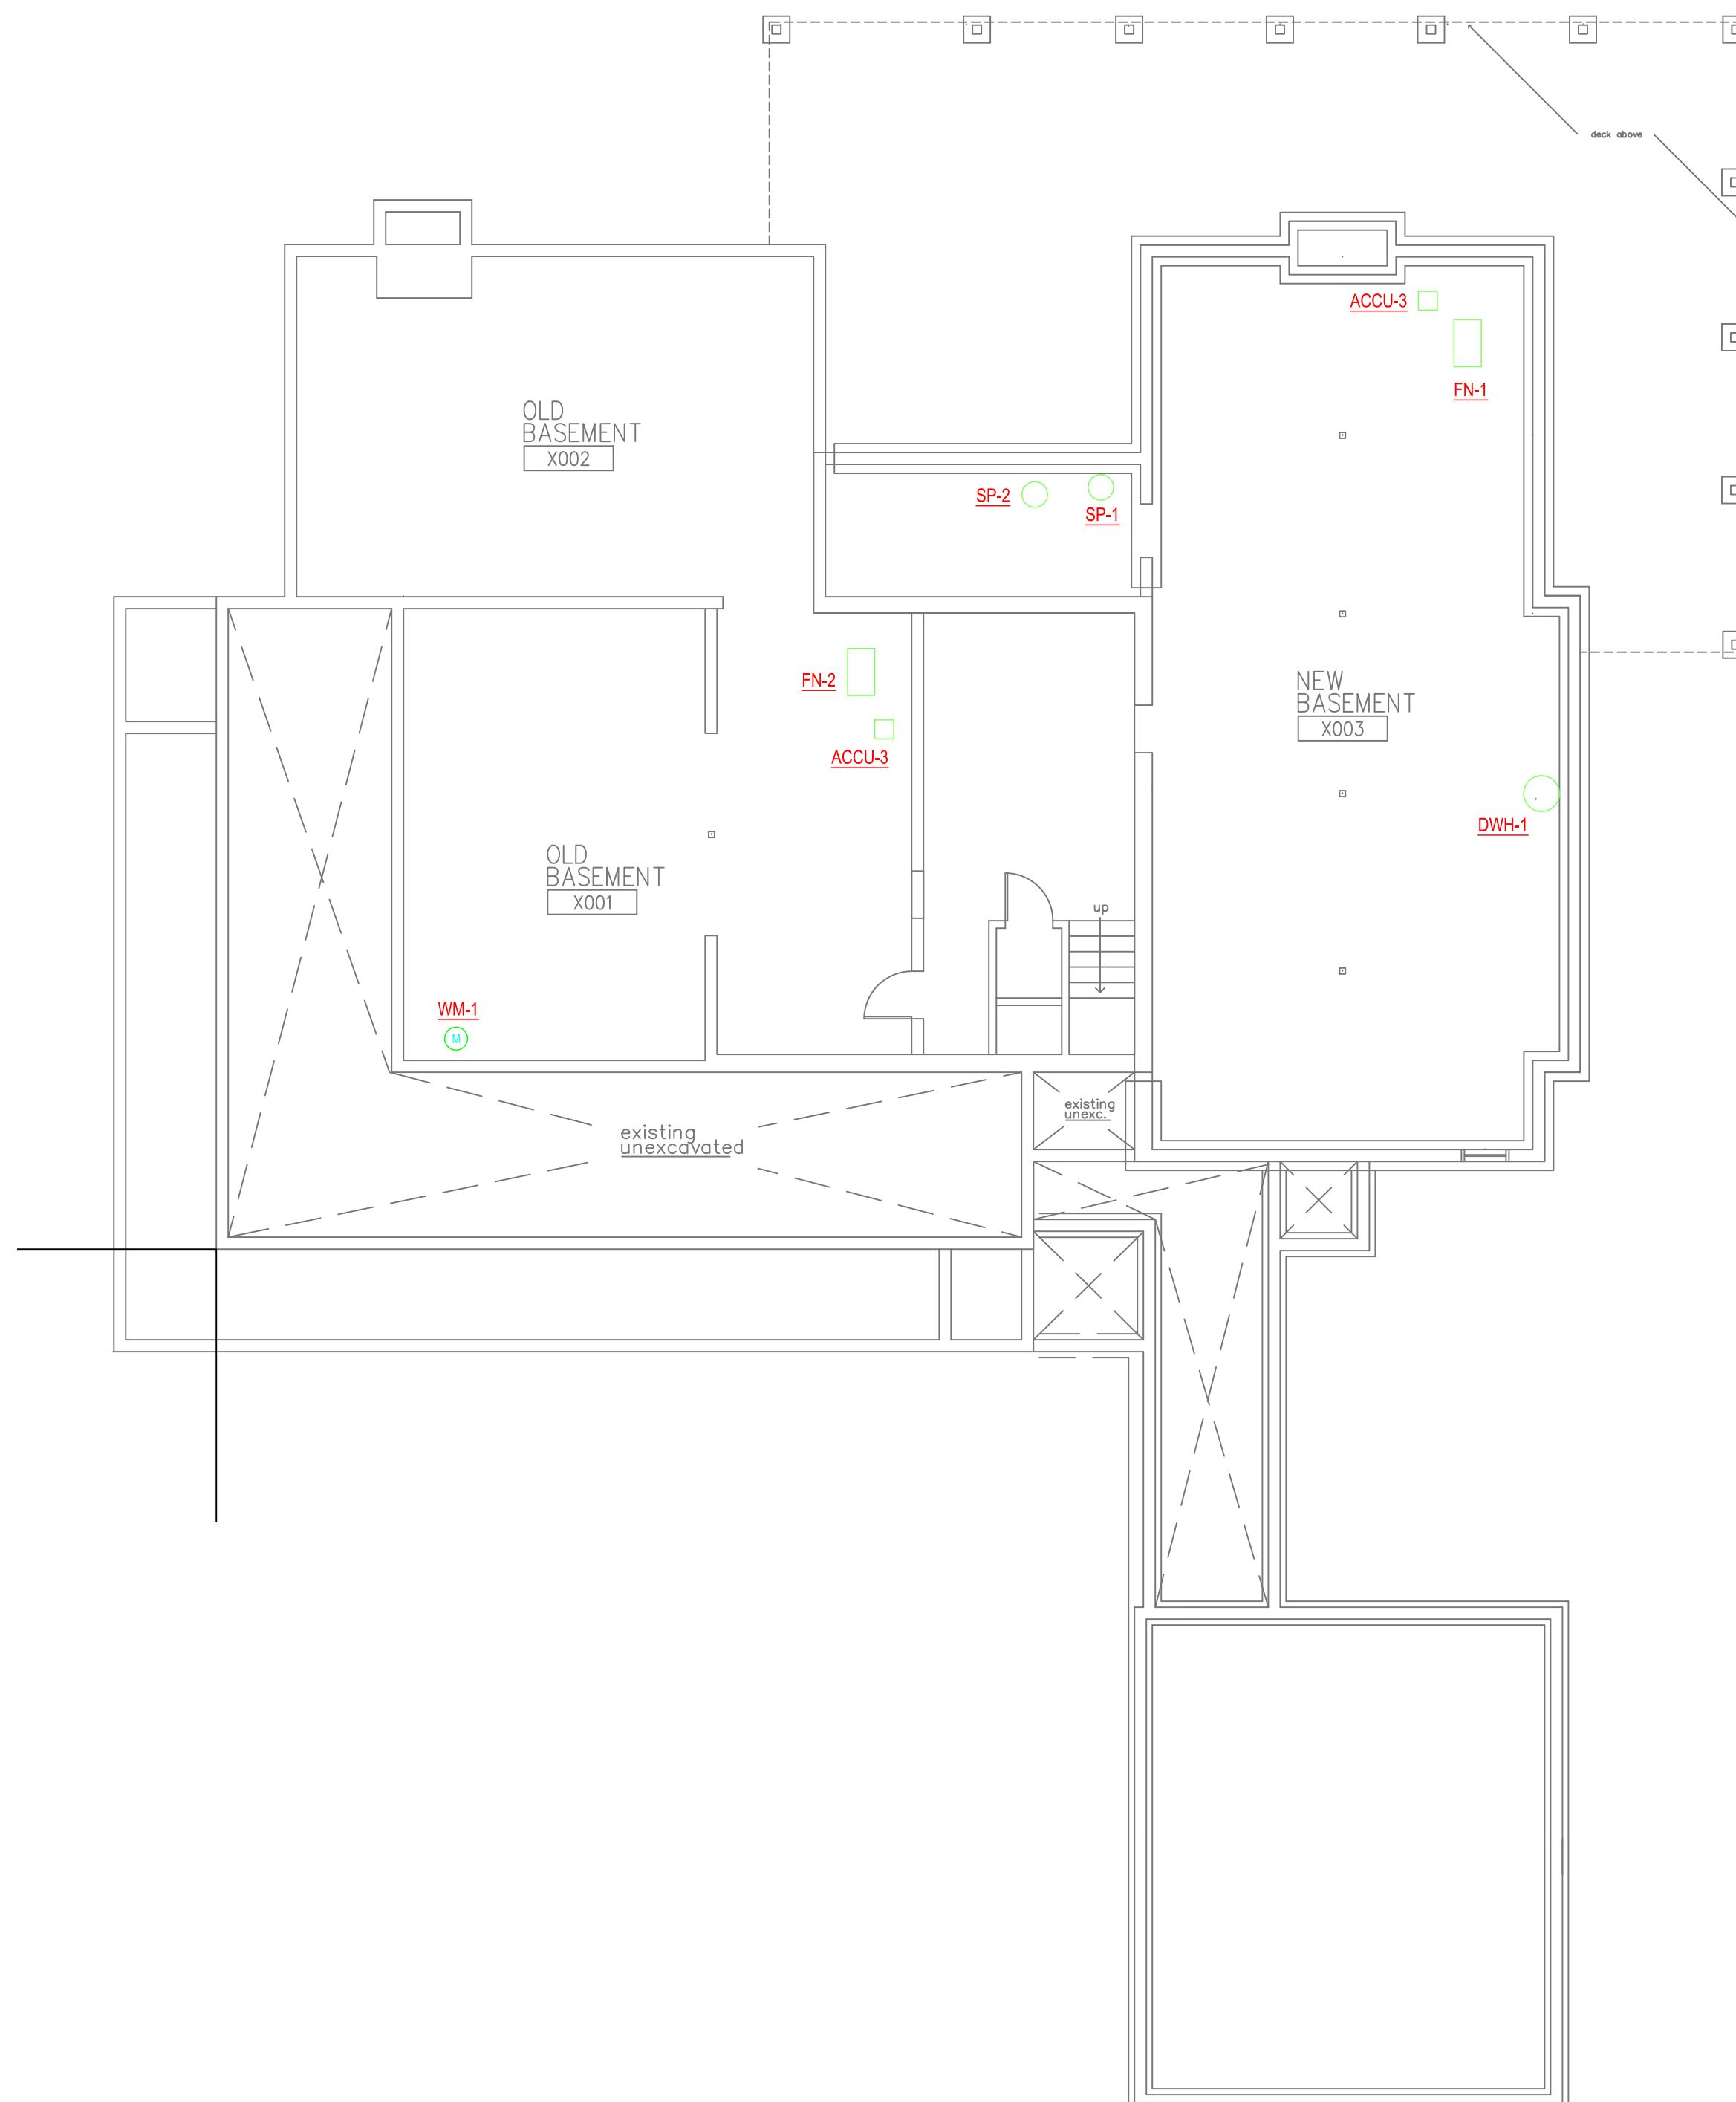
DESIGNER:	KLE
MODELLER:	EKS
PM:	ATW
PIC:	BJR
ACADFILE:	20-0501-M101.DWG
PROJECT No.	20-0501.00
SHEET TITLE	FARM HOUSE BASEMENT MECHANICAL PLAN
SHEET NUMBER	M-101

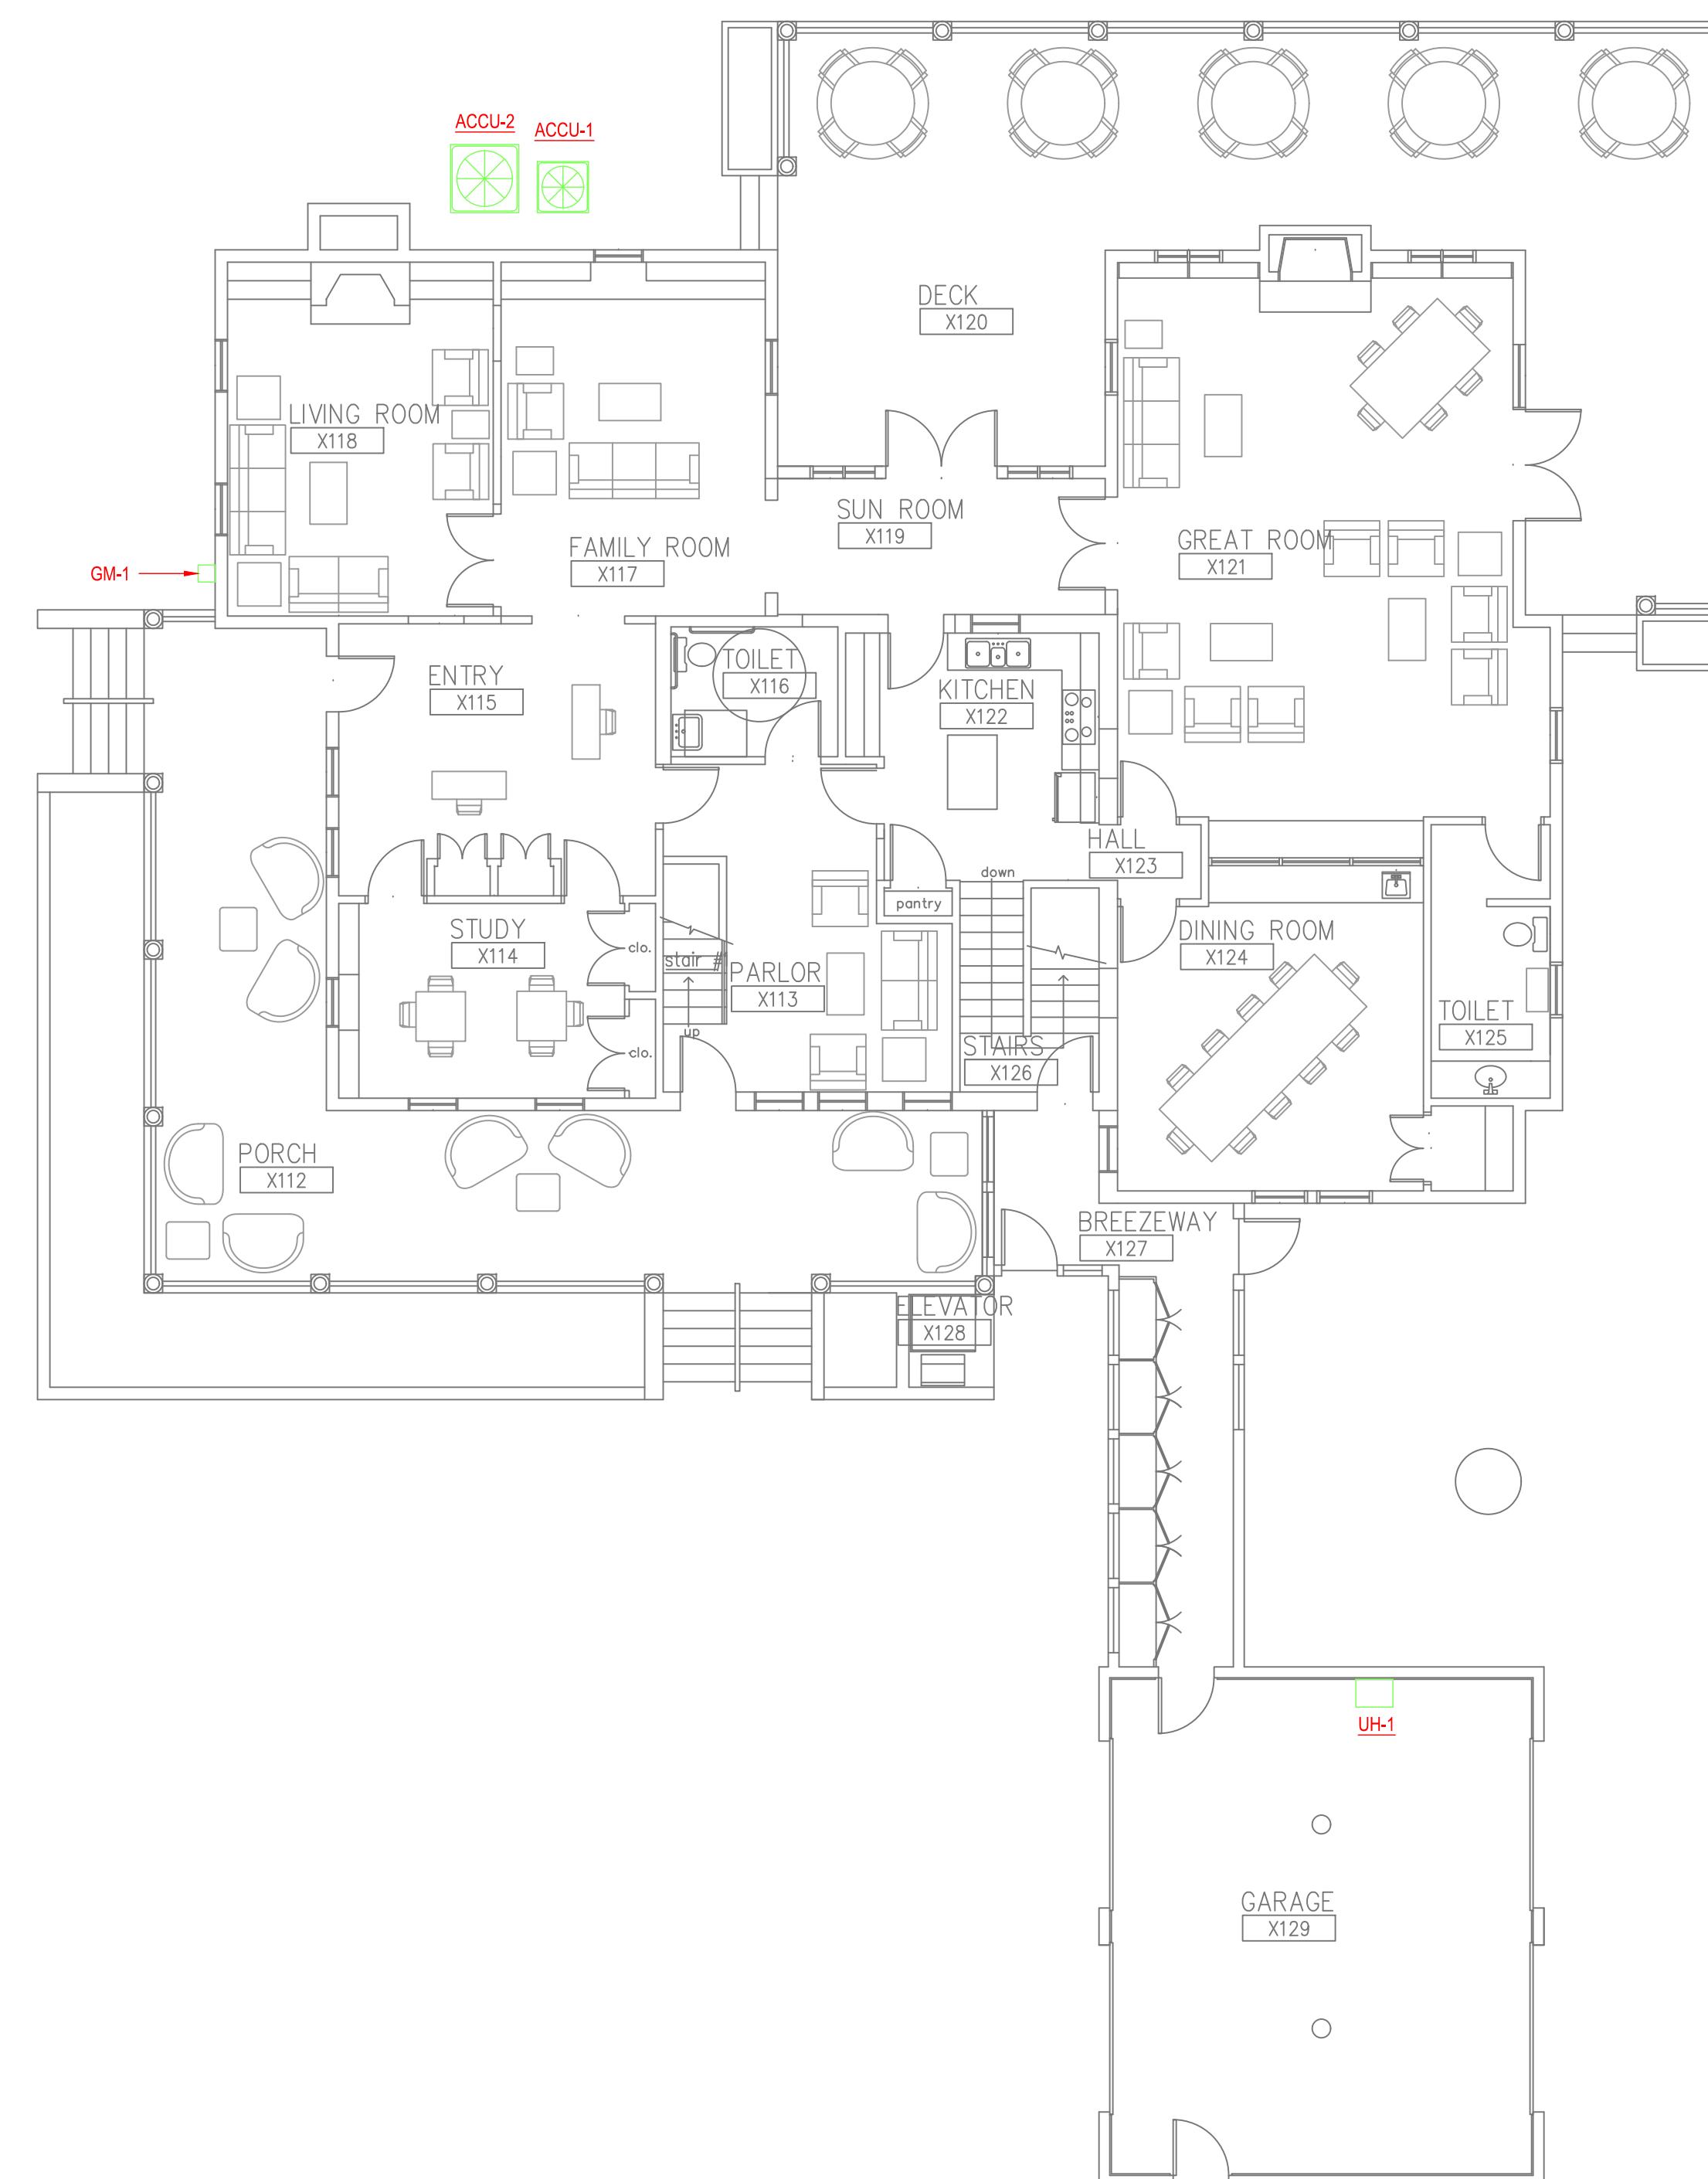
NORTH  
FARM HOUSE FIRST FLOOR  
MECHANICAL PLAN  
SCALE: 1/8" = 1'-0"  
0 4 8 16 Feet

DESIGNER:	KLE
MODELER:	EKS
PM:	ATW
PIC:	BUR
ACADFILE:	2020-0501.00
PROJECT No:	20-0501.00
SHEET TITLE	FARM HOUSE FIRST FLOOR MECHANICAL PLAN
SHEET NUMBER	M-102
