# **DELTA COLLEGE**

## **FACILITIES CONDITION ASSESSMENT**

DSD Project No. 20-0501

UNIVERSITY CENTER, MICHIGAN

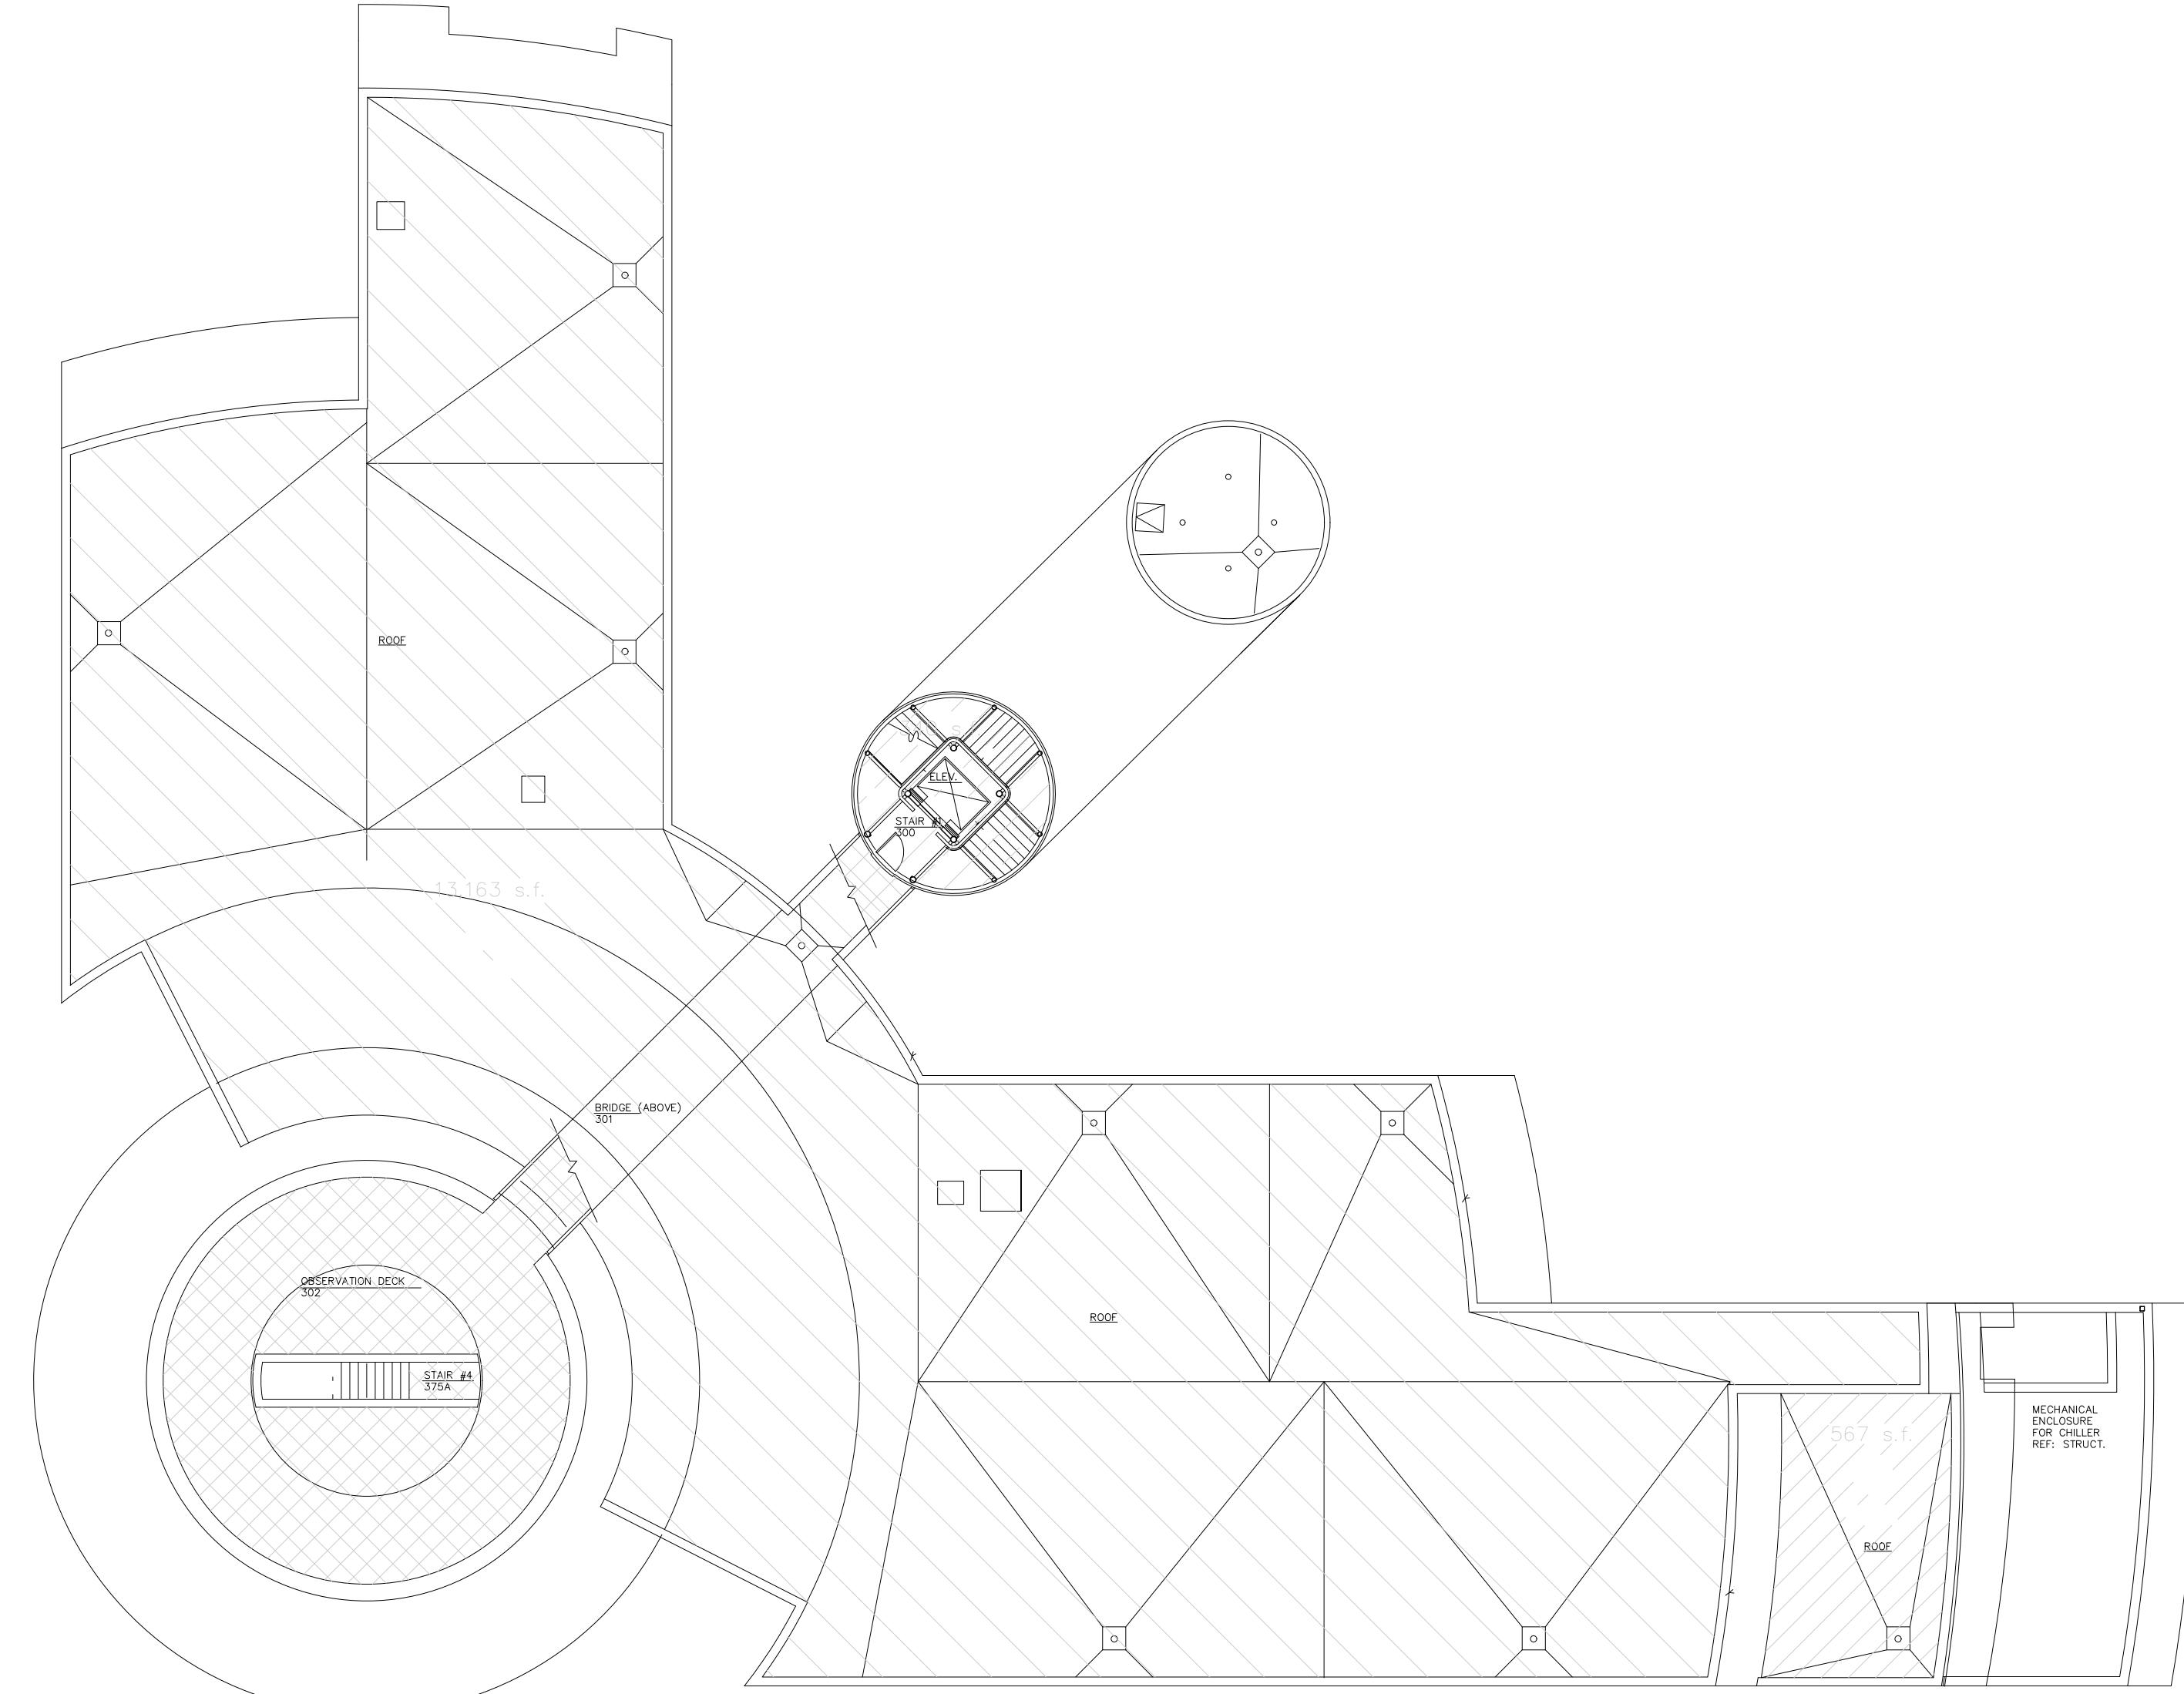
**ROOF COMPOSITE PLAN**

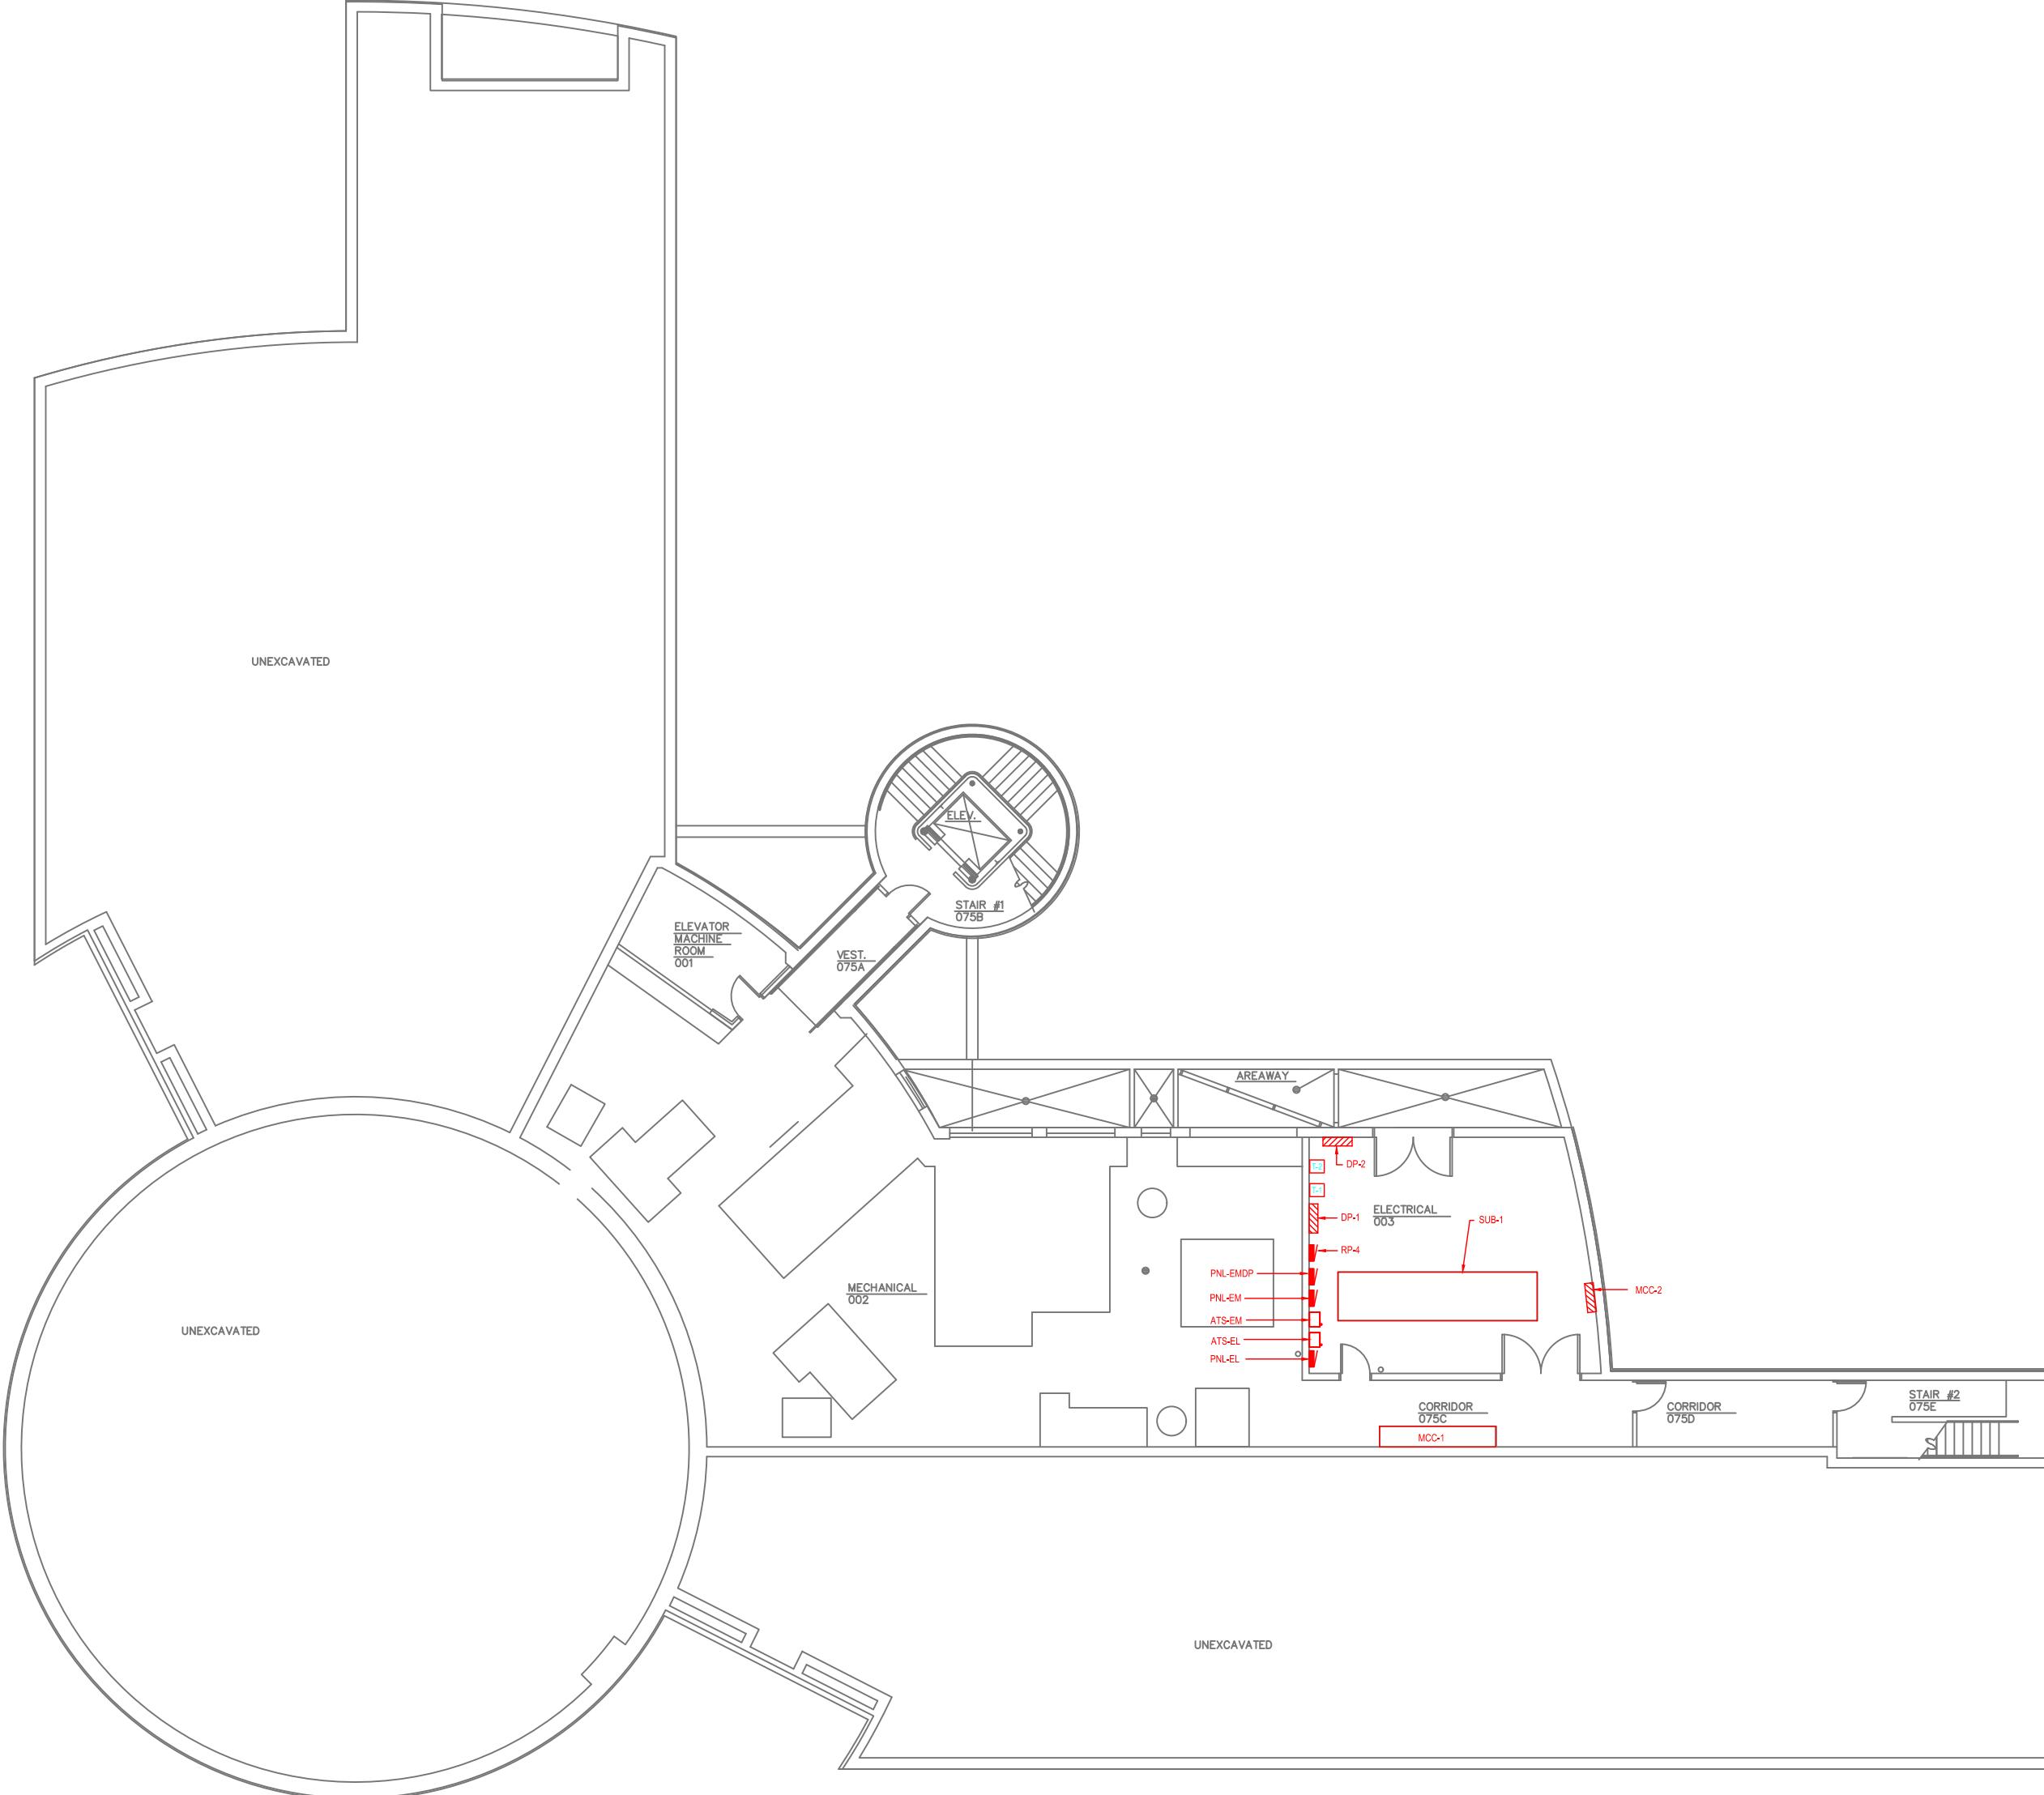
**BASEMENT FLOOR  
ELECTRICAL PLAN**

SCALE: 1/16" = 1'-0"

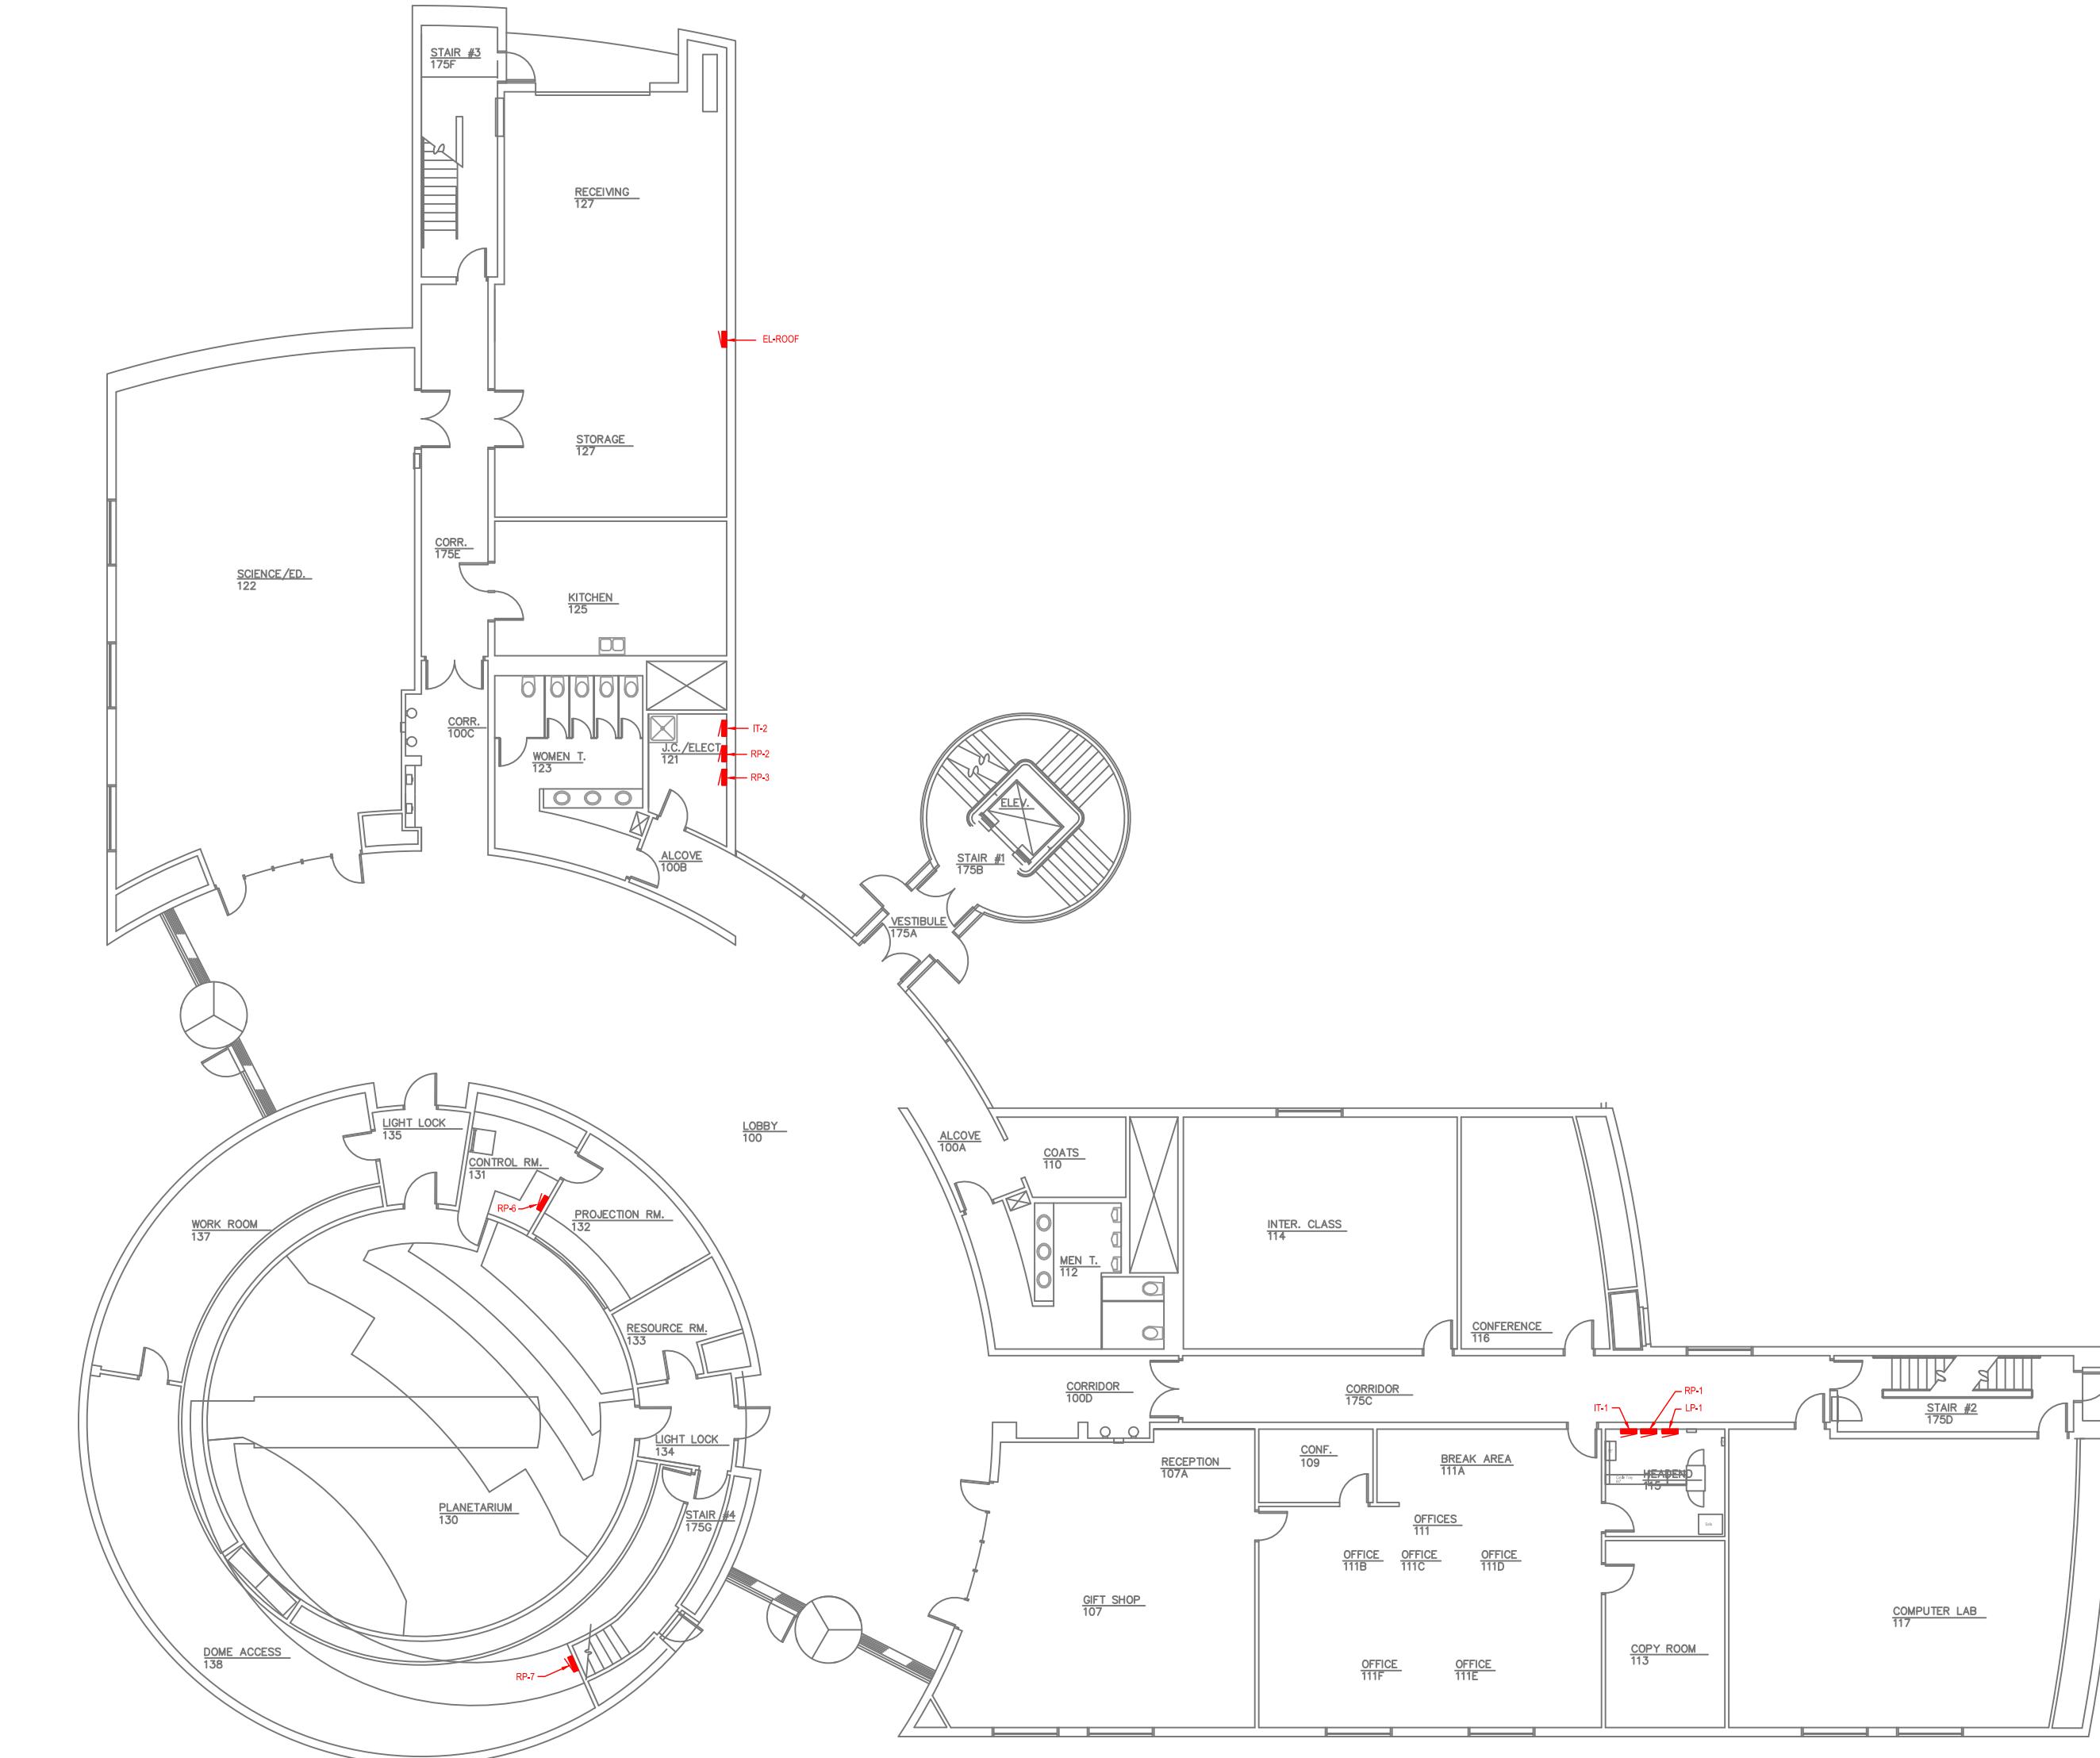
**FIRST FLOOR  
ELECTRICAL PLAN**

SCALE: 1/16" = 1'-0"

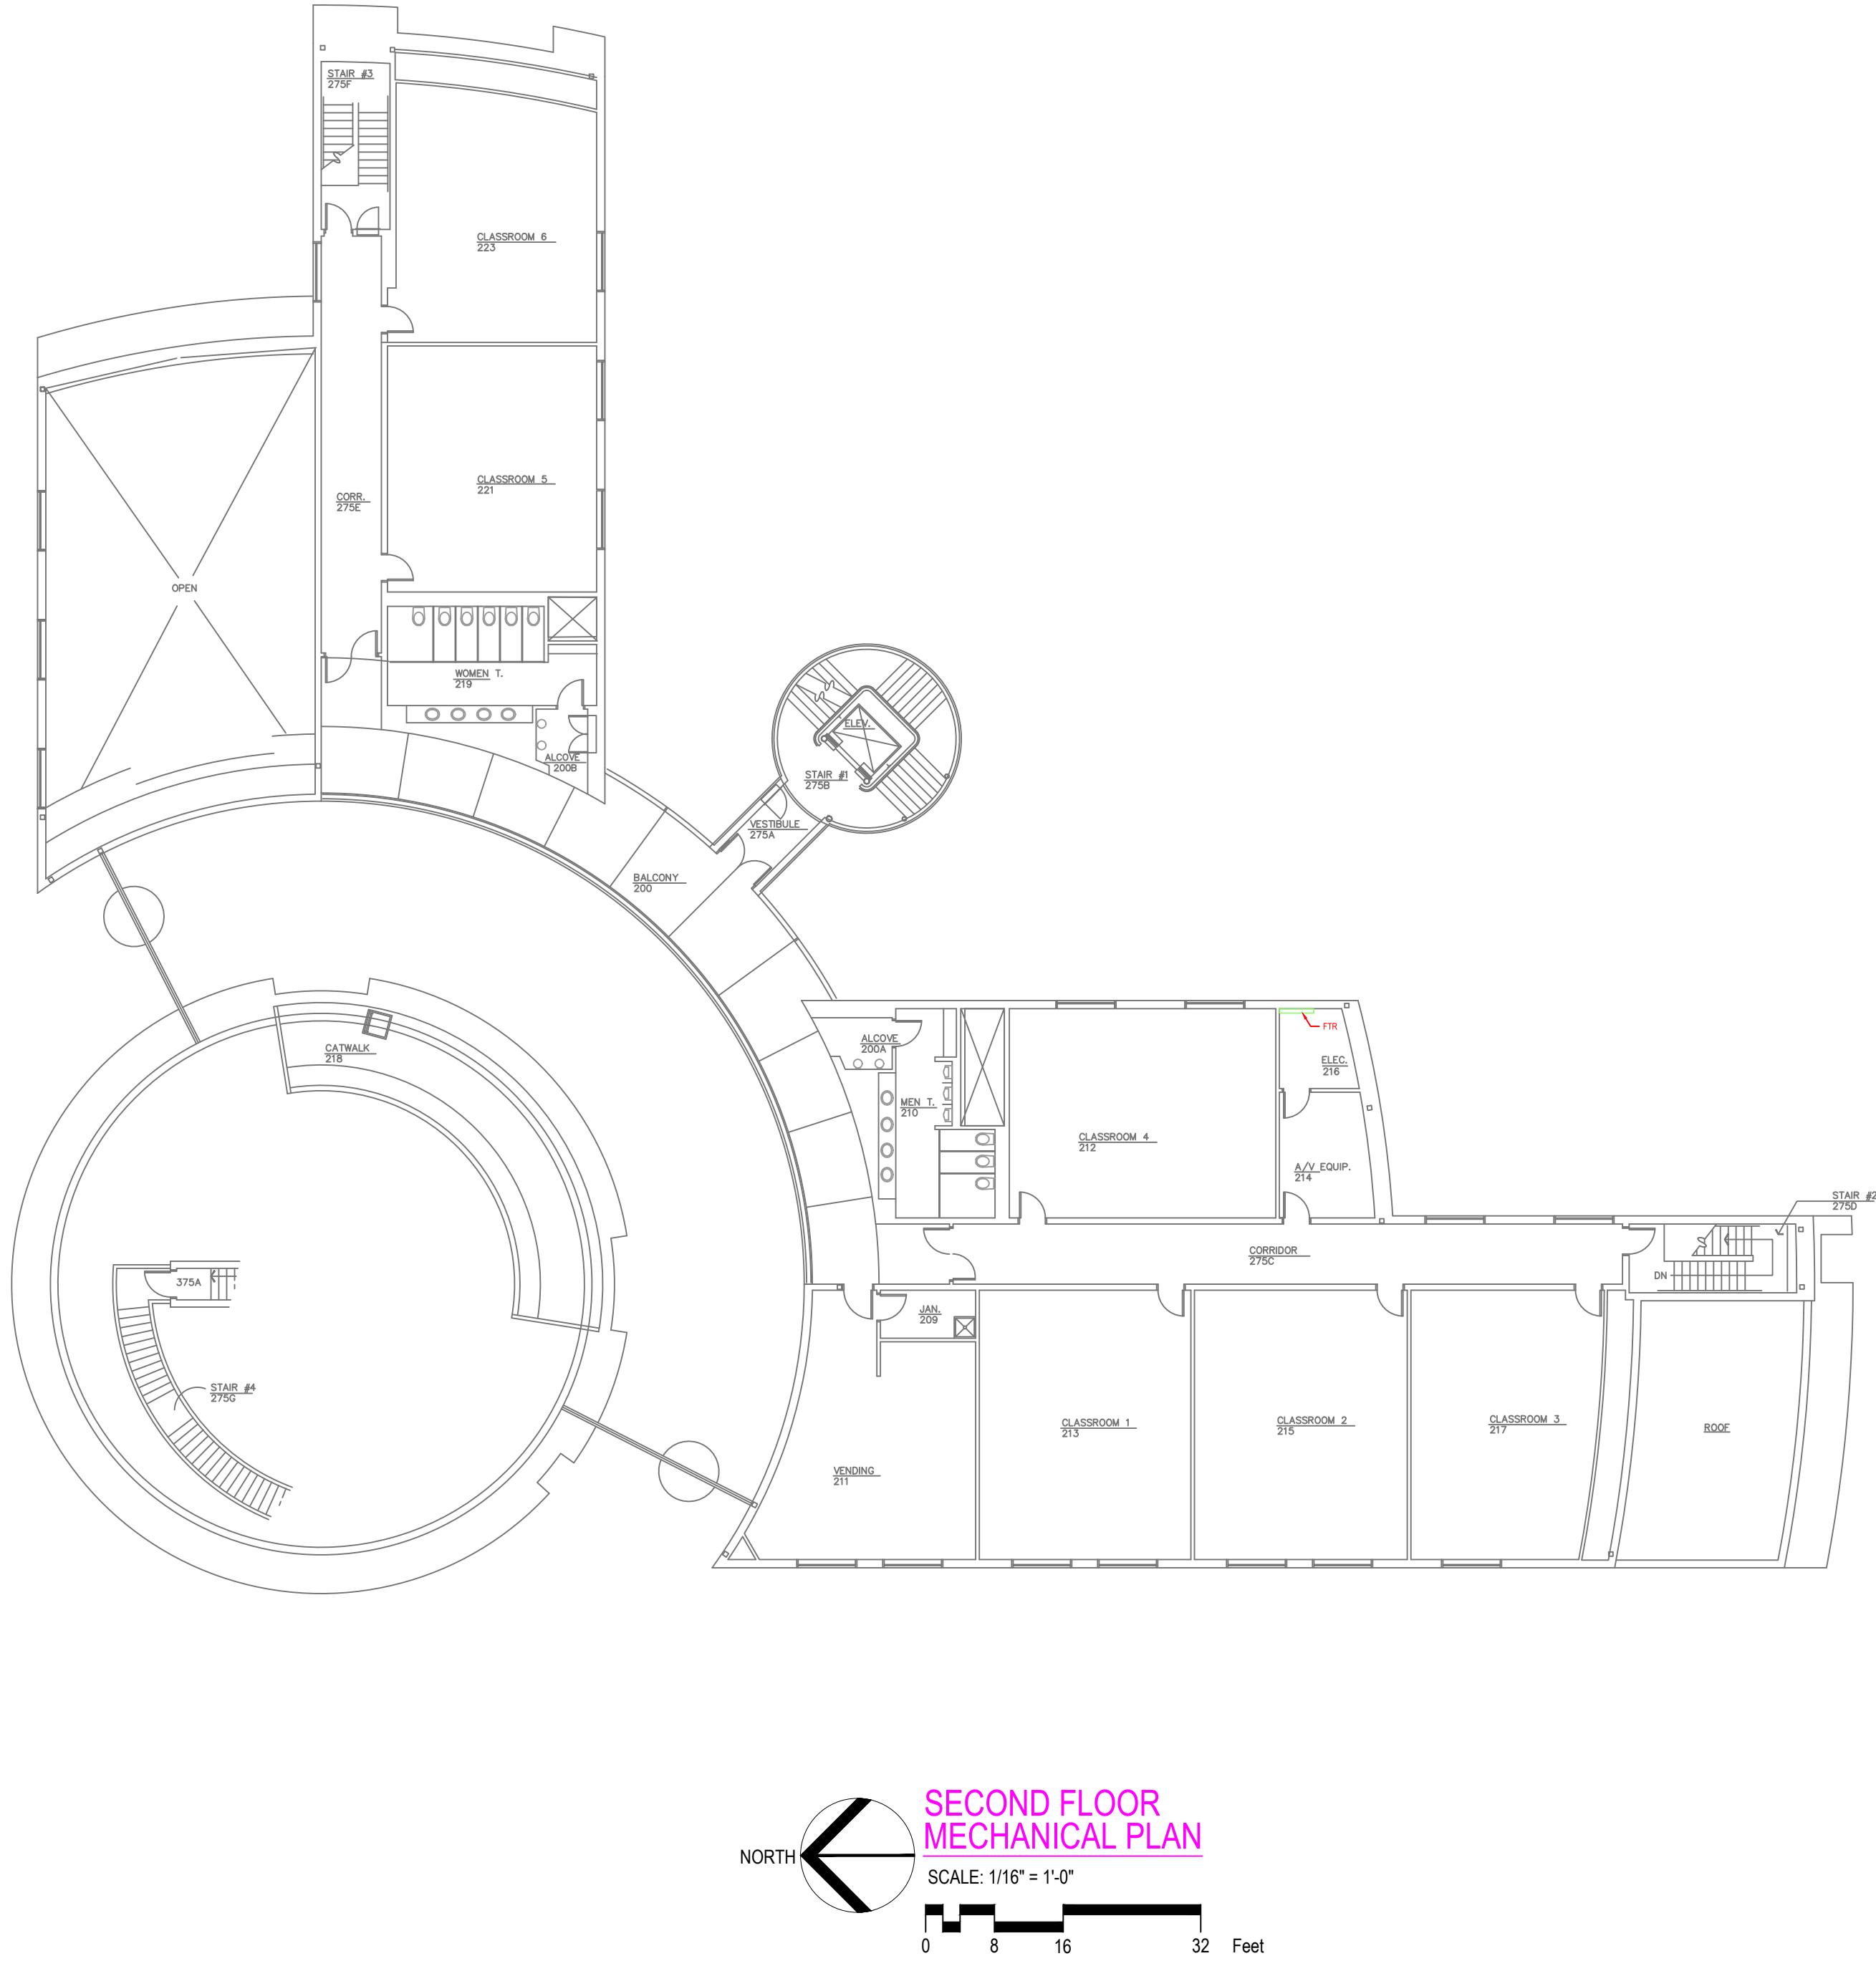
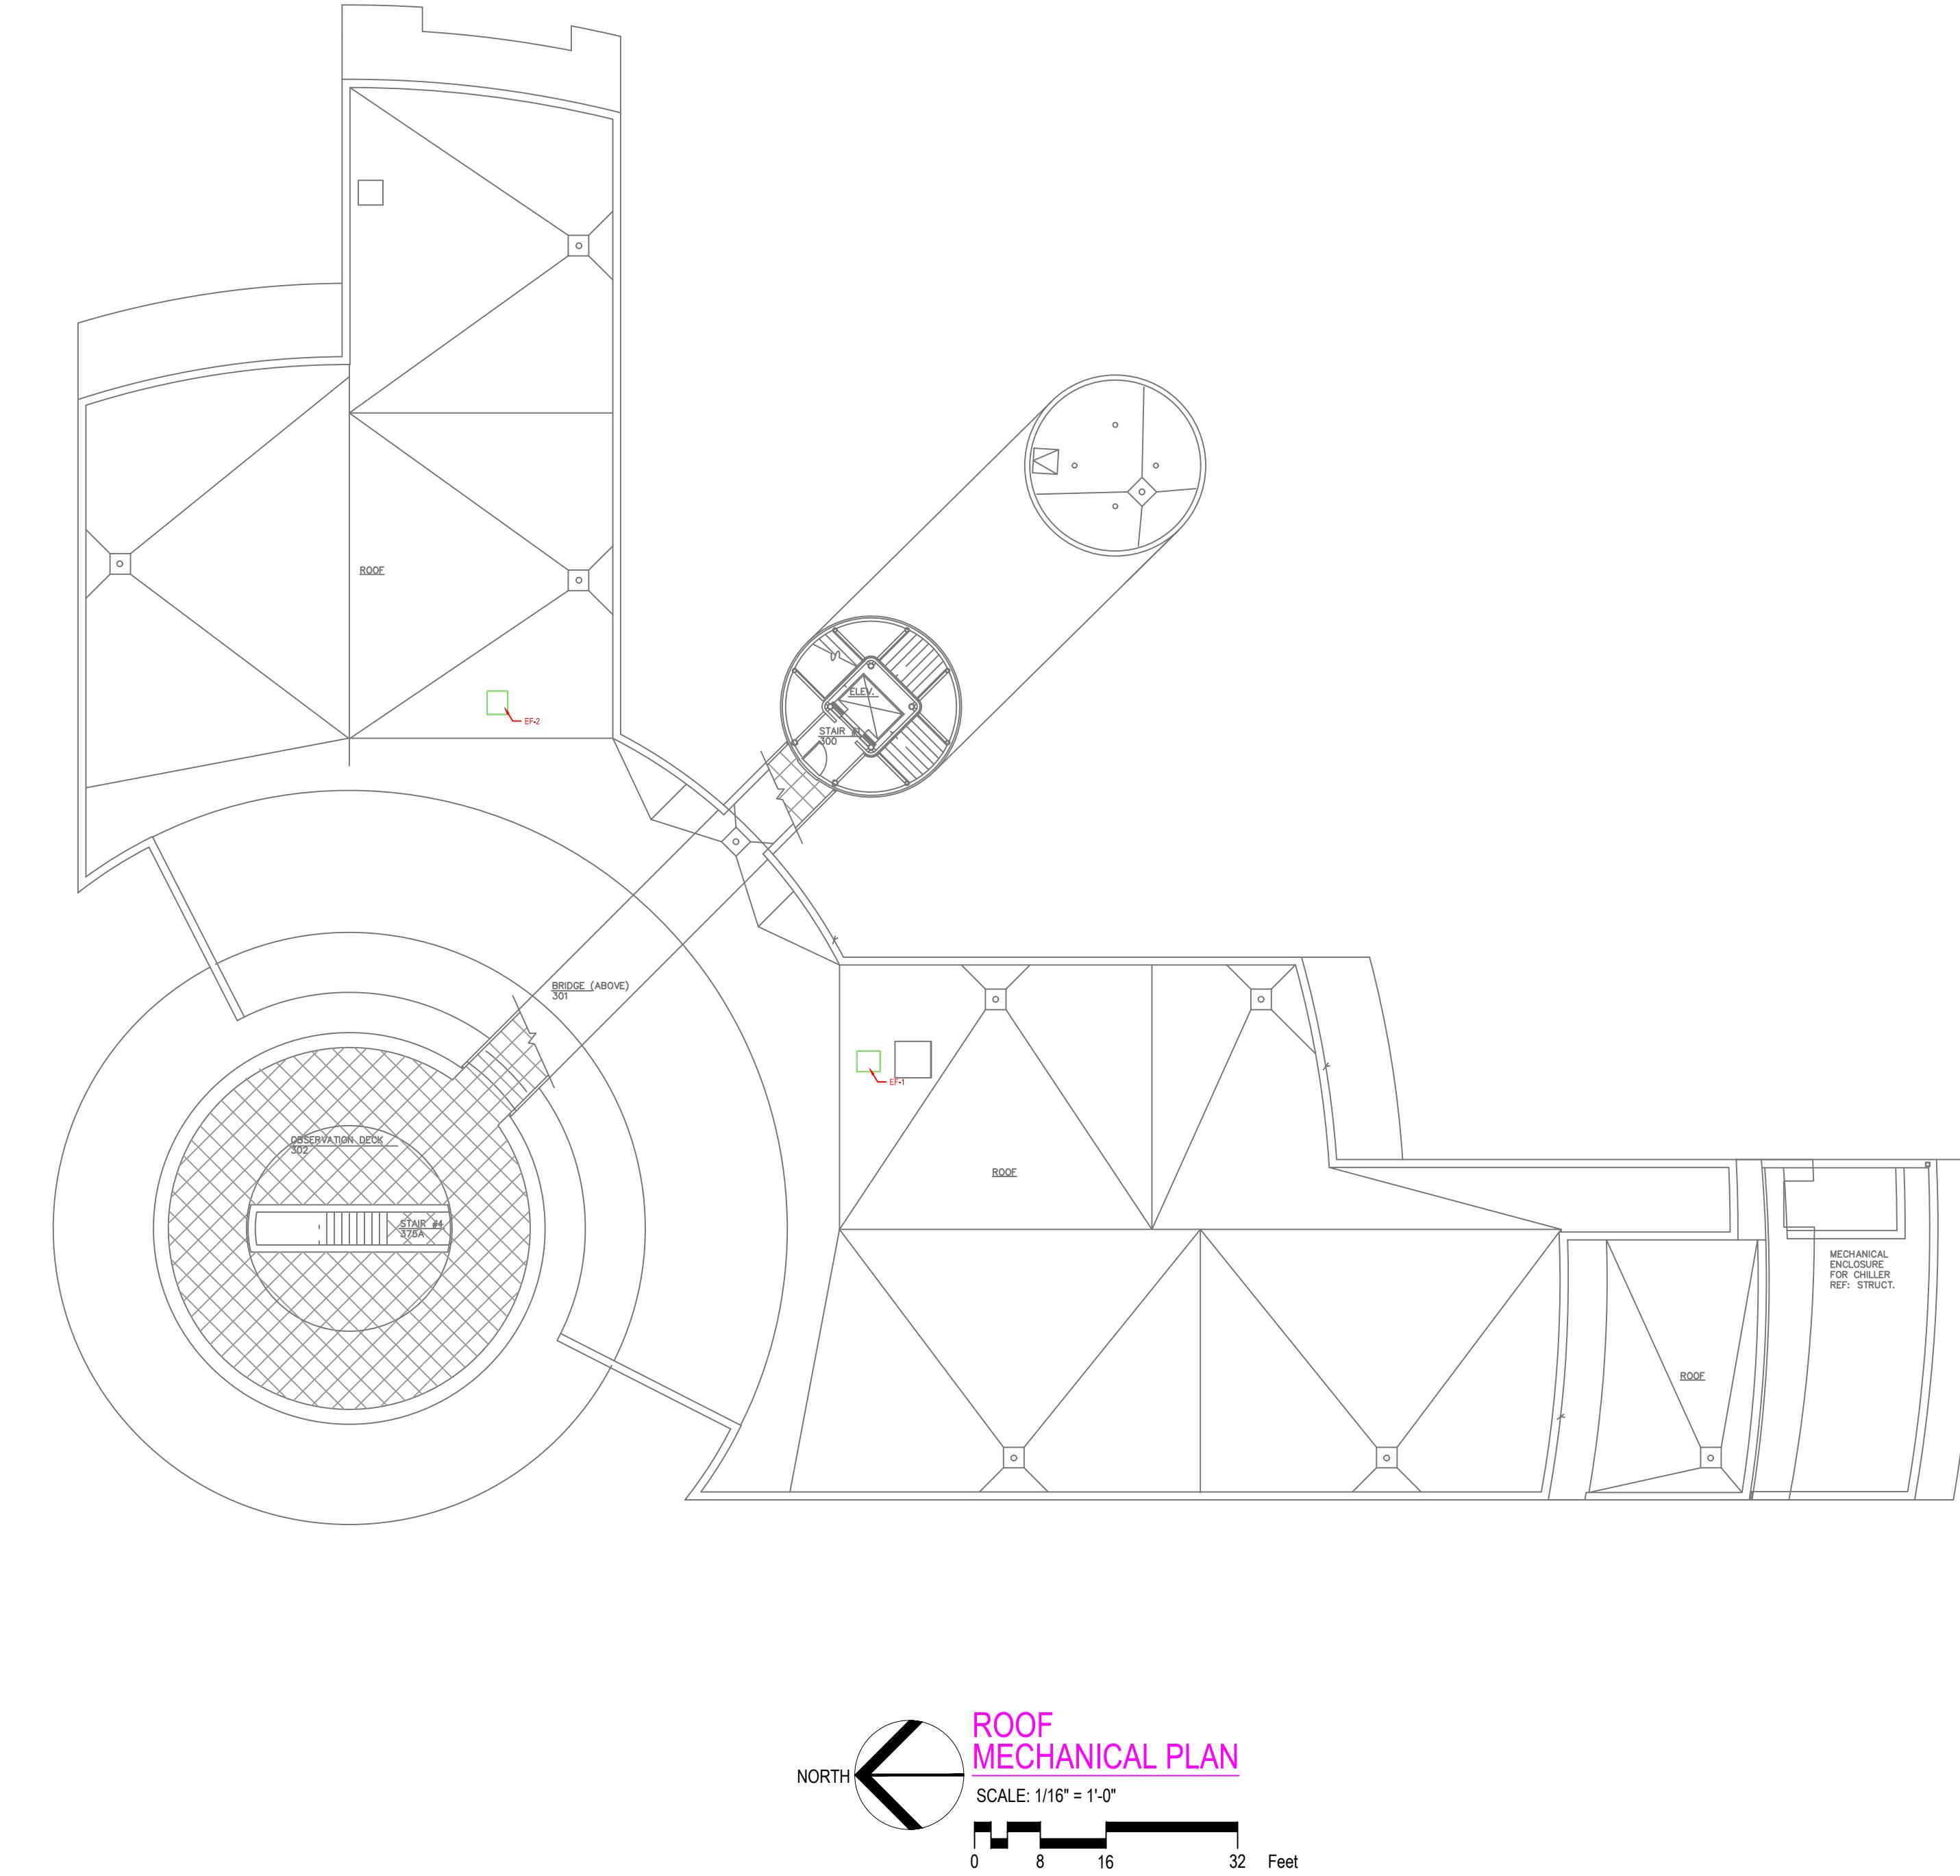
OWNER:	KLE
SELLER:	EKS, JDL
	ATW
	BJR
FILE:	20-0501-M-002.DWG
ECT No.	20-0501.00
TTITLE	PLANETARIUM SECOND FLOOR & ROOF MECHANICAL PLAN
T NUMBER	M-002

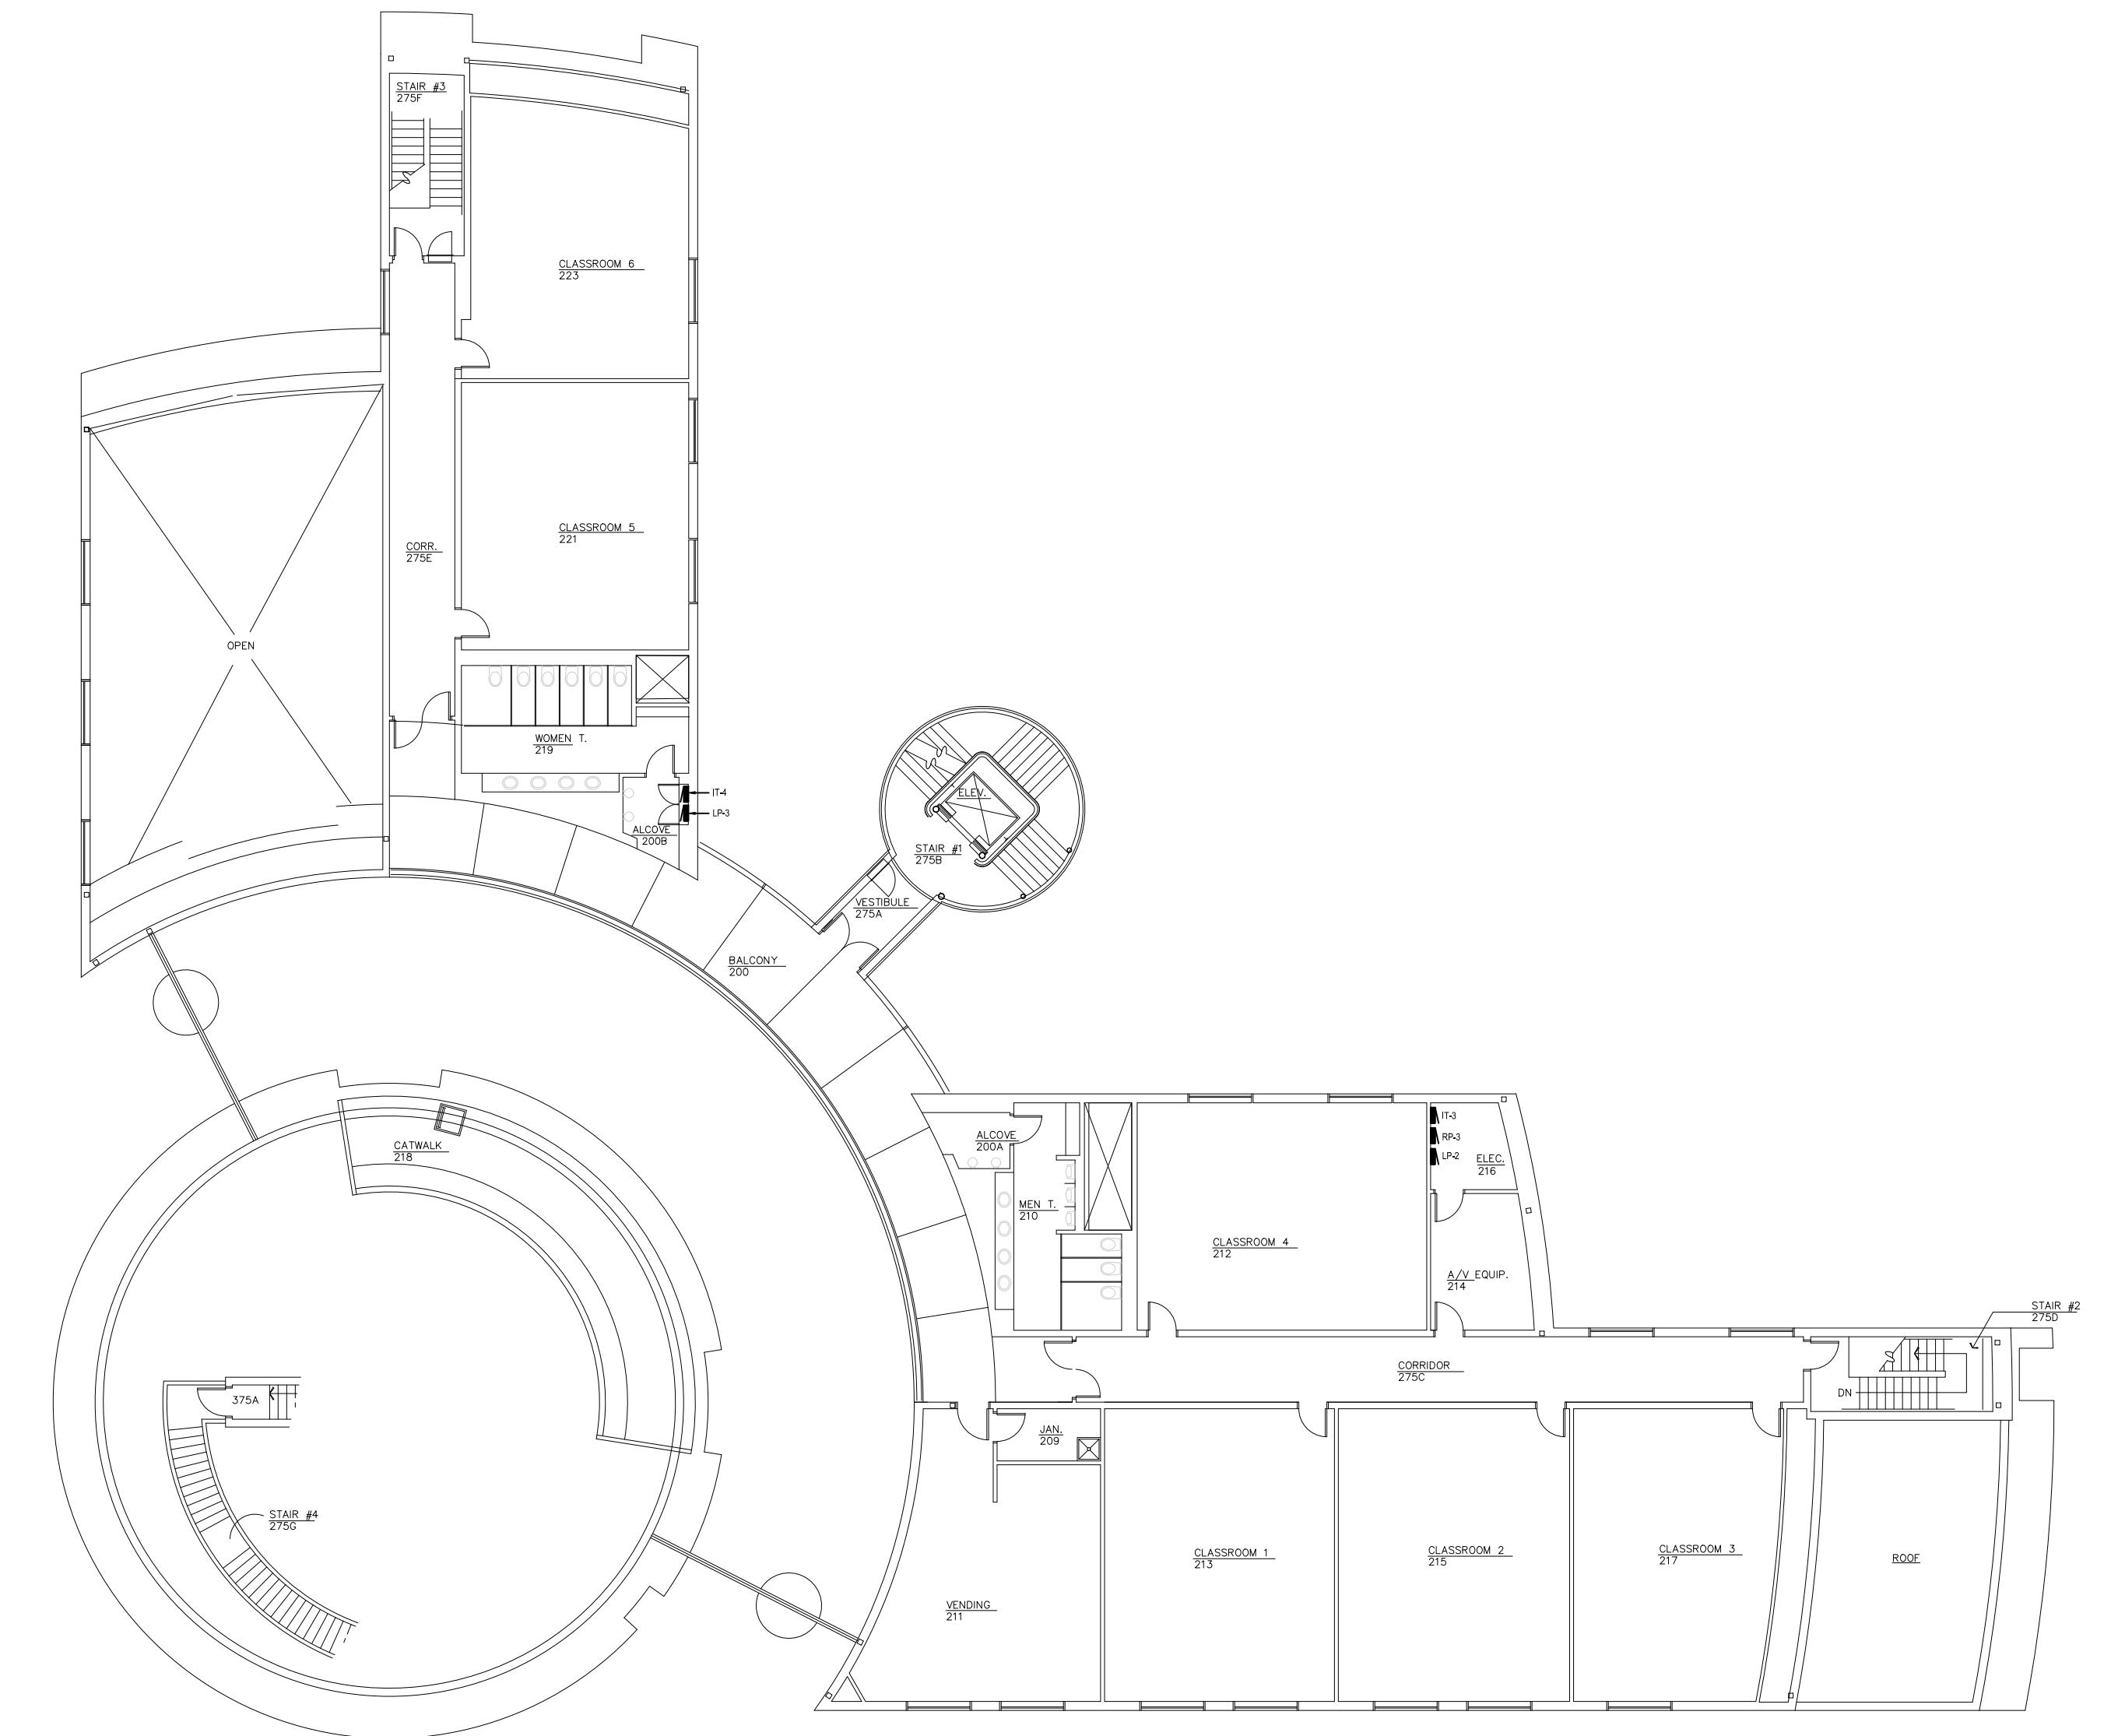
E-002

PLANETARIUM  
SECOND FLOOR  
ELECTRICAL PLAN
